Service Information

Category S	Repair Guidance	Ref. No. R038/14	Page 1 of 3
Coverage <input type="checkbox"/> Distributor only <input checked="" type="checkbox"/> Please inform your dealers		Date Issued April 25, 2014	
Please convey this information to your <input type="checkbox"/> Director <input checked="" type="checkbox"/> General Manager <input checked="" type="checkbox"/> Warranty Dept. <input checked="" type="checkbox"/> Parts Dept. <input checked="" type="checkbox"/> Training Dept. <input checked="" type="checkbox"/> Field Rep.		Date Revised	
Applicable Model Mazda3 (BM)		Applicable Countries or Specifications Worldwide

Subject: Side(s) of Rear Seat Cushion is loose

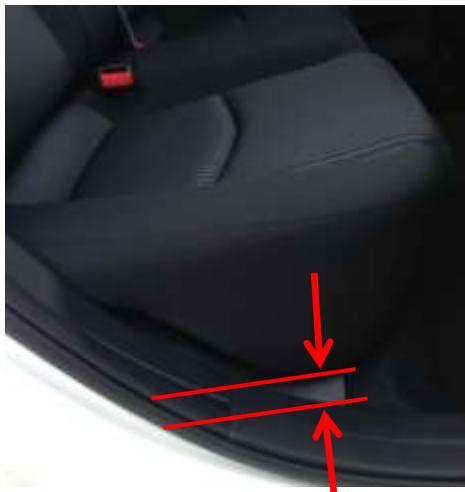
Looks floating above floor carpet

Due to product variation of the rear seat cushion, some may have a larger clearance between the cushion and the floor carpet.

When you receive a customer complaint on this concern, fix the both sides of rear seat cushion to the floor carpet by using Velcro tapes. Refer to the below procedure.

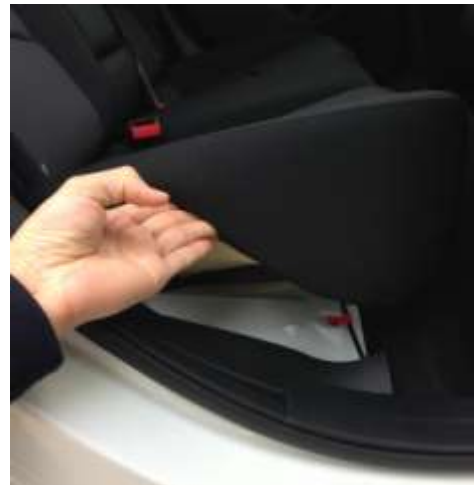
It wobbles when lifting by hand.
