Service Information

Category T	Repair Guidance	Ref. No. R035/14	Page 1 of 3
Coverage <input type="checkbox"/> Distributor only <input checked="" type="checkbox"/> Please inform your dealers		Date Issued March 31, 2014	
Please convey this information to your <input type="checkbox"/> Director <input checked="" type="checkbox"/> General Manager <input checked="" type="checkbox"/> Warranty Dept. <input checked="" type="checkbox"/> Parts Dept. <input checked="" type="checkbox"/> Training Dept. <input checked="" type="checkbox"/> Field Rep.		Date Revised	
Applicable Model Mazda3(BM) with Mazda Connect		Applicable Countries or Specifications Europe

Subject: Traffic Alert (TA) is broadcasted although TA mode is switched off

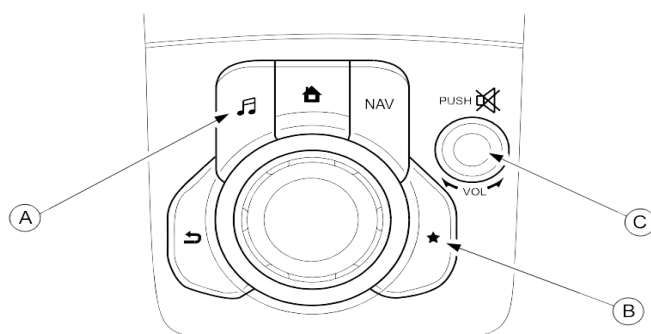
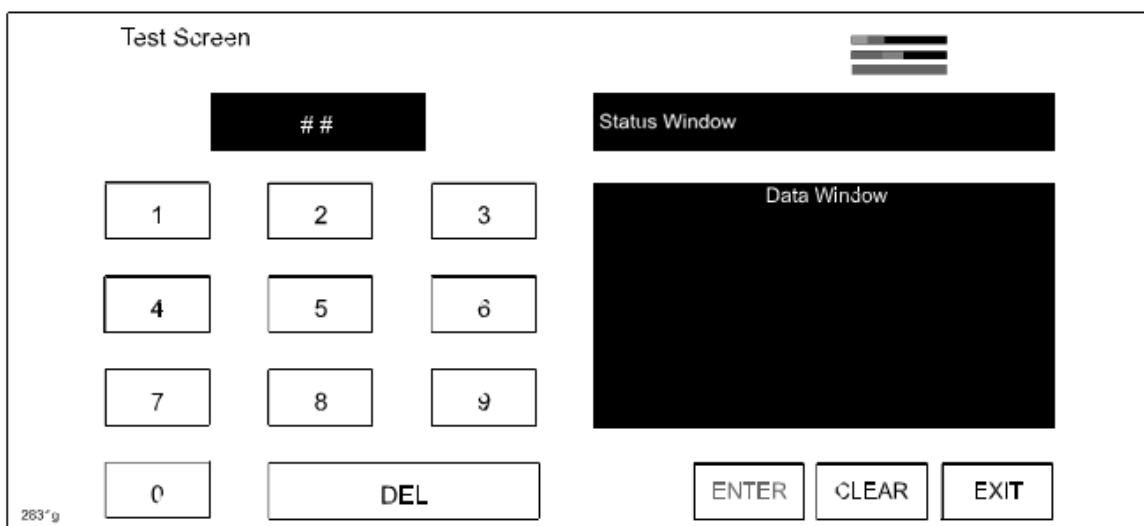
1. Press the three buttons (Music (A) + Favorites (B) + Volume Mute(C)) on the commander switch at the same time for 2-5 seconds and the Diagnostic Test Screen will appear.

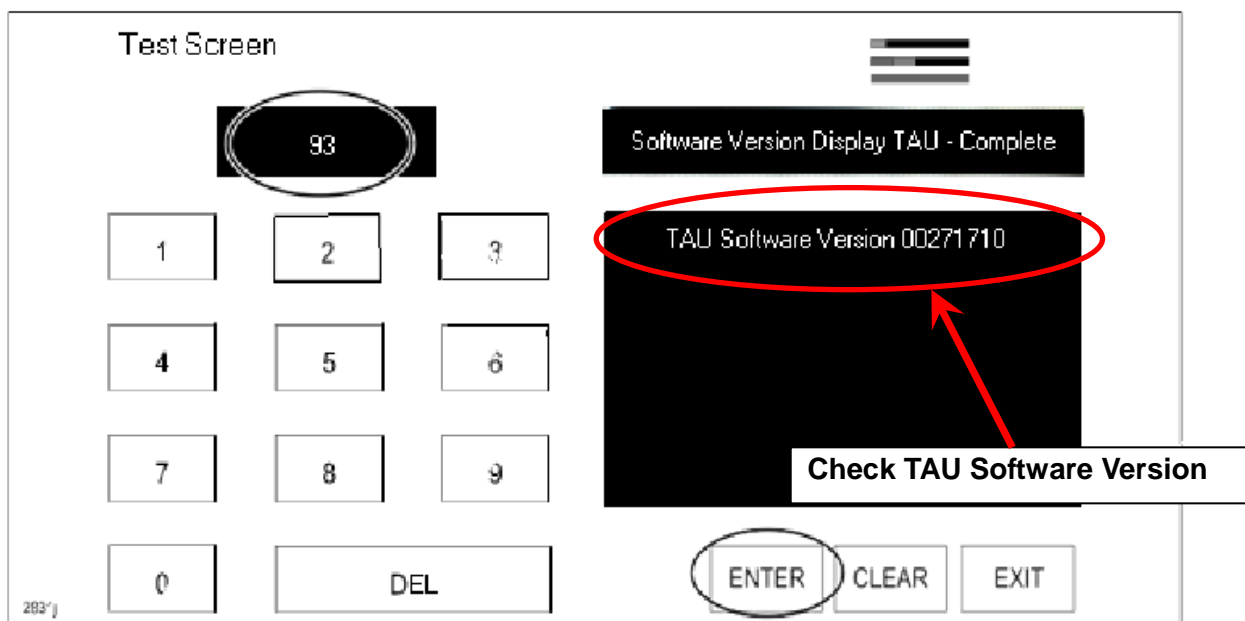
2. Use the touchscreen or the commander switch to input '93' and then select "ENTER" on the Test screen.
3. Check the TAU Software Version as shown in illustration.

- If the TAU software version is "00291801" or lower, replace the TAU with a modified one.
- If the TAU software version is "00301801" or higher, this Service Information is not applicable.
