Category T	Repair Guidance	Ref. No. R026/14	Page 1 of 3
Coverage <input type="checkbox"/> Distributor only <input checked="" type="checkbox"/> Please inform your dealers		Date Issued February 27, 2014	
Please convey this information to your <input type="checkbox"/> Director <input checked="" type="checkbox"/> General Manager <input checked="" type="checkbox"/> Warranty Dept. <input checked="" type="checkbox"/> Parts Dept. <input checked="" type="checkbox"/> Training Dept. <input checked="" type="checkbox"/> Field Rep.		Date Revised	
Applicable Model Mazda3 (BM)	Applicable Countries or Specifications Worldwide

Subject: Vibration of Active Driving Display Combiner

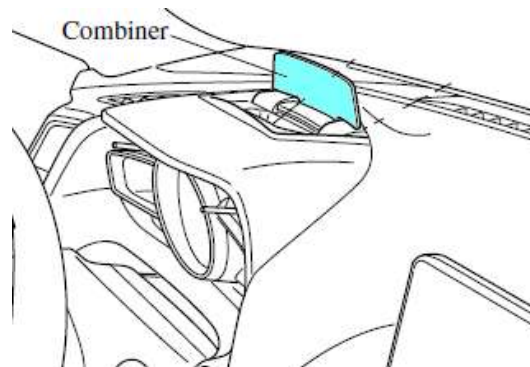
Some customers may complain that the combiner of the Active Driving Display (ADD) vibrates when driving over a road bump or it is impossible to adjust the angle of the ADD up to the viewable position by the commander switch.

The customer might open/close the ADD combiner manually or close the ADD combiner with objects being placed in the ADD combiner storage area, causing the axis of the ADD combiner to pop out of the position.
