Service Information

Mazda Motor Corporation

Subject: i-Stop Warning Light flashing, Master Warning Light & Charging System Warning Light illumination and a message "Charging System Malfunction/Engine could stop unexpectedly" in LCD (DTC P1794 and P2502)

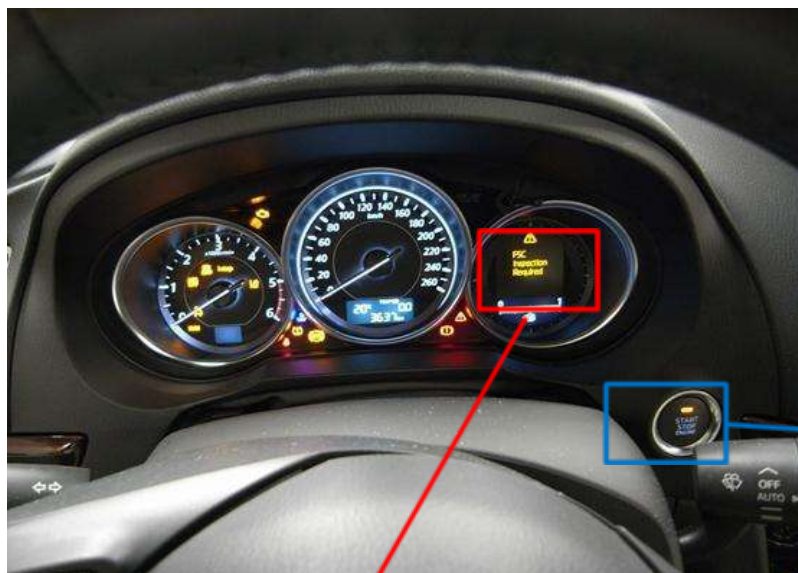
Note: During PCM reprogramming, some vehicles may show some warning messages with flashing Start stop switch. This is caused by reset function of ABS/DSC CU not working properly.

Start Stop switch light flashes.

1. After PCM reprogramming has been finished, turn the IG-off by pushing Start Stop switch for long time (around 3 seconds) to turn off.
2. After that, disconnect **ABS/DSC S 30A** Fuse for 30 seconds so that the system is reset back to normal.

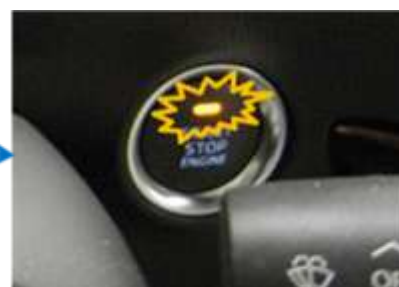
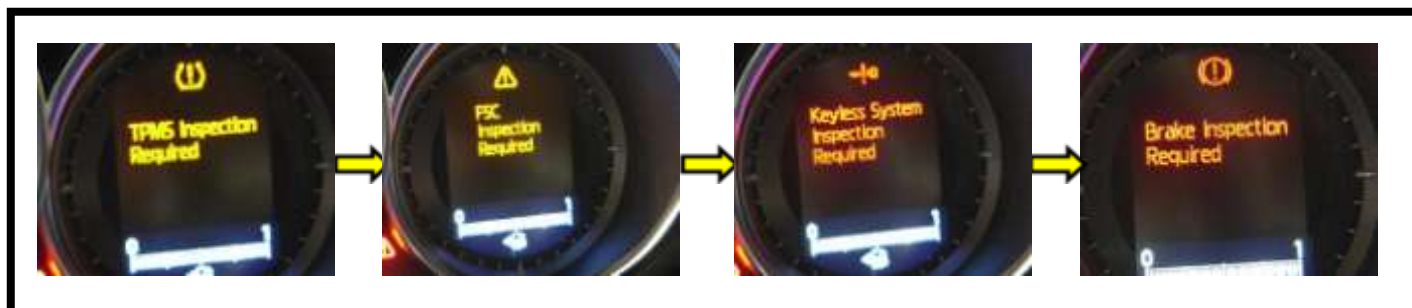
Below warning messages are displayed.

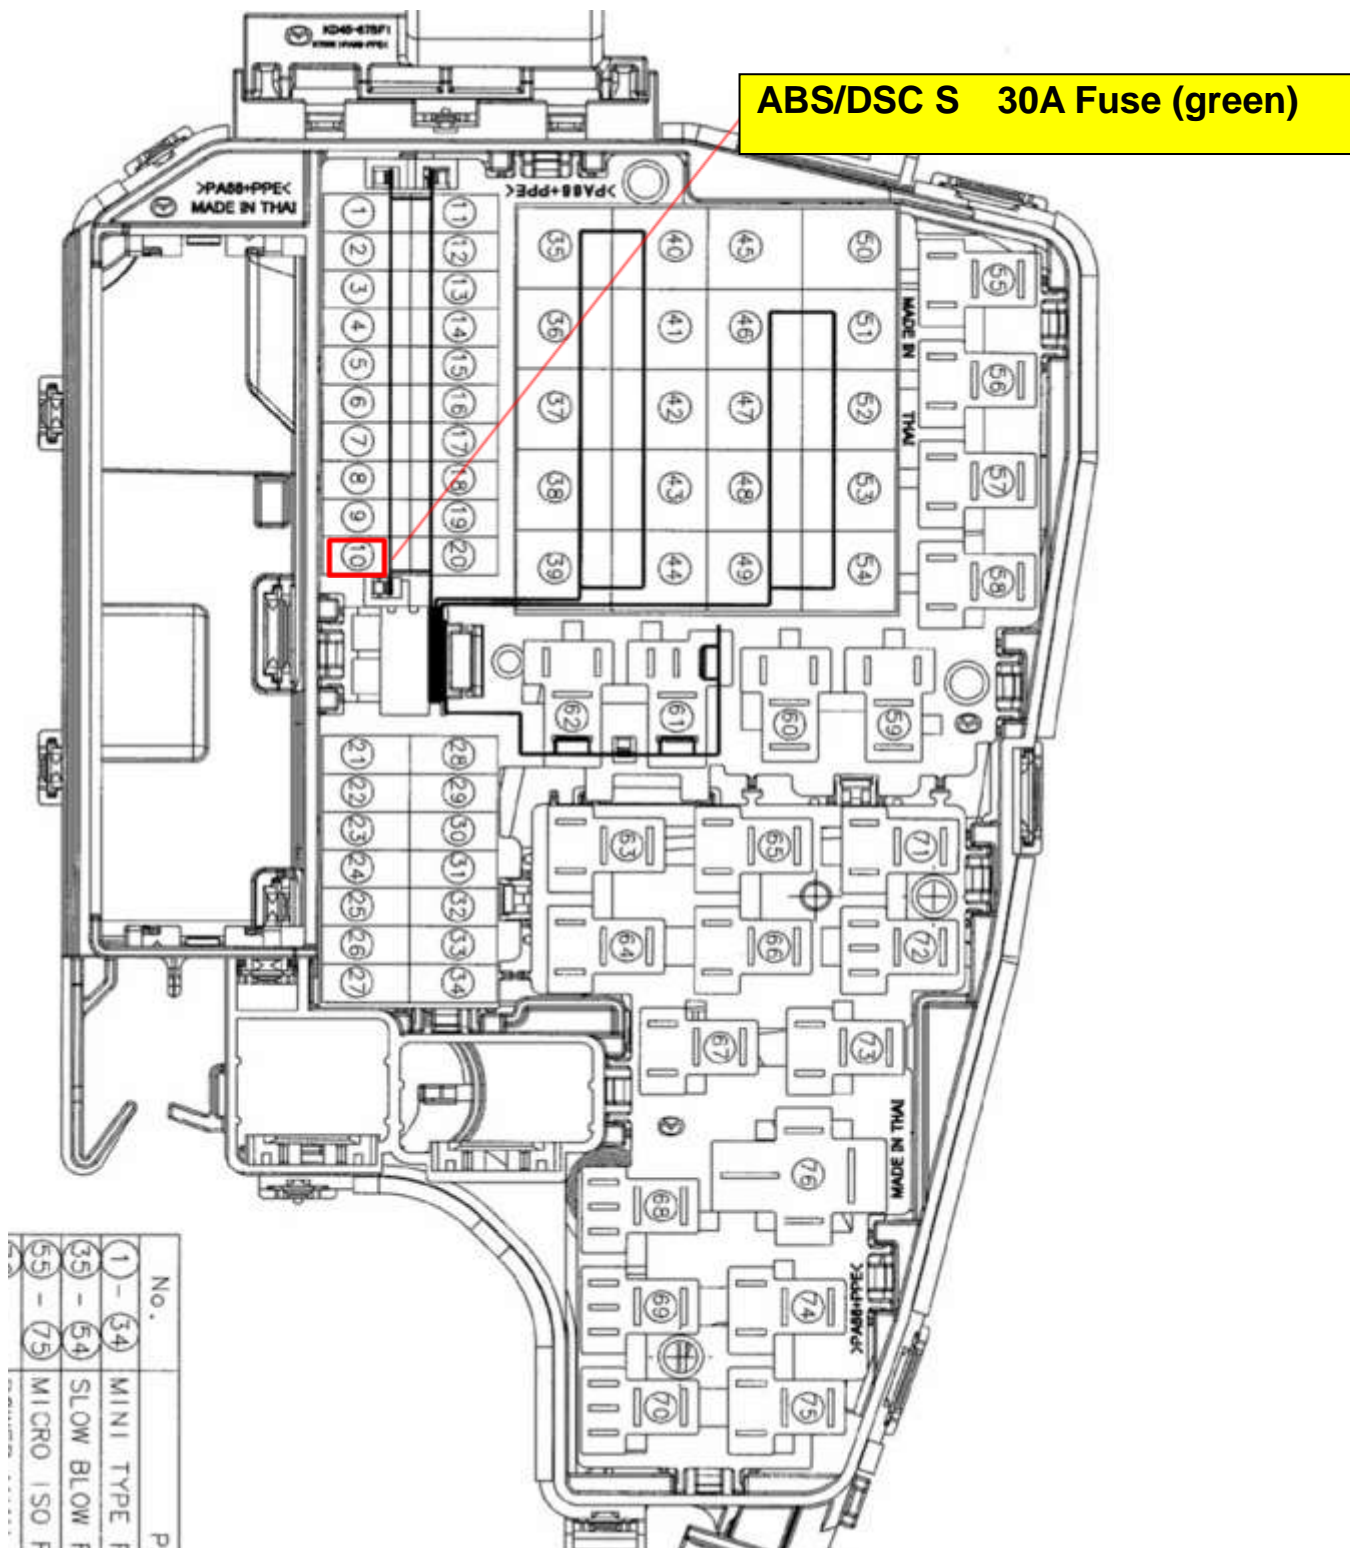
Note: There is a similar named fuse "ABS/DSC M 50A. Be sure to avoid confusion.
