Service Information

Category S	Repair Guidance	Ref. No. R098/13	Page 1 of 4
Coverage <input type="checkbox"/> Distributor only <input checked="" type="checkbox"/> Please inform your dealers		Date Issued November 22, 2013	
Please convey this information to your <input type="checkbox"/> Director <input checked="" type="checkbox"/> General Manager <input checked="" type="checkbox"/> Warranty Dept. <input checked="" type="checkbox"/> Parts Dept. <input checked="" type="checkbox"/> Training Dept. <input type="checkbox"/> Field Rep.		Date Revised	
Applicable Model CX-5 (KE)		Applicable Countries or Specifications Europe

Subject: Bonnet vibrates when driving at more than 110Km/h

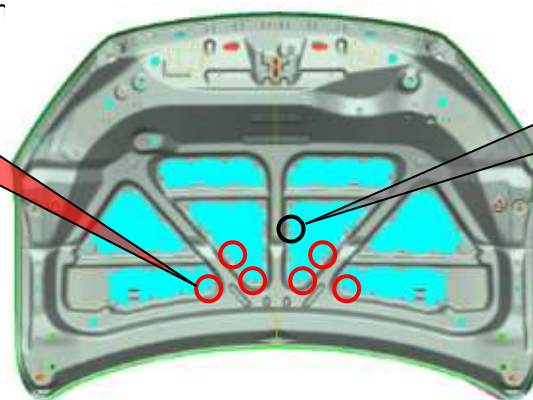
1. Adhesive filled in the space between the outer panel and the inner frame at the back of the bonnet may be not adequate and separating leading to bonnet vibration. **In addition to this, the adhesive may be separating by high pressurized water being applied when cleaning the bonnet at the production line.**
2. **The preload forces of the cowl grill seal may be insufficient which can also affect the bonnet vibration adversely.**

<Defective adhesive condition
(It is coming off.)>

<Proper adhesive condition>
(It adheres to panel and frame.)>

1. Verify customer complaint.
2. Replace the cowl grill seal with a modified one with increased preload force.
3. Inspect the factory applied adhesive between the outer panel and the inner frame at the rear of the bonnet whether it has separated or not.
 - If the adhesive is separated, go to STEP 3 and apply additional adhesive in between the outer panel and inner frame at the rear of the bonnet.
 - If the factory applied adhesive is not separated, go to STEP 5.
