Service Information

Category T	Repair Guidance	Ref. No. R082/13A	Page 1 of 7
Coverage <input type="checkbox"/> Distributor only <input checked="" type="checkbox"/> Please inform your dealers		Date Issued October 15, 2013	
Please convey this information to your <input type="checkbox"/> Director <input checked="" type="checkbox"/> General Manager <input checked="" type="checkbox"/> Warranty Dept. <input checked="" type="checkbox"/> Parts Dept. <input checked="" type="checkbox"/> Training Dept. <input checked="" type="checkbox"/> Field Rep.		Date Revised April 24, 2014	
Applicable Model CX-5(KE)		Applicable Countries or Specifications UK and Ireland

Subject: Electrical System Malfunction(s) in connection with failure of C-15 Connector

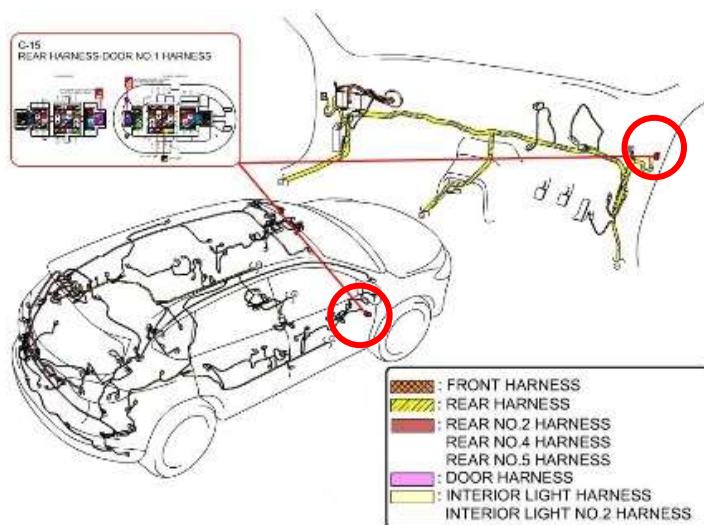
C-15 Connector

Some vehicles may experience one or more of the following symptoms in connection with failure of the C-15 connector.

This concern is caused by corroded terminals of the C-15 connector due to water intrusion into the front door. At low ambient temperature, the door harness gets hardened. With this condition, if the door is fully opened, it may create a gap between the front door and the door harness grommet allowing water adhered to the front door to enter through the gap.

- If there is any corrosion at the C-15 connector, replace the door harness and repair the rear harness according to the following repair procedure.
- If there is no corrosion found at the C-15 connector, this Service Information is not applicable. Troubleshoot the concern according to the Workshop Manual.

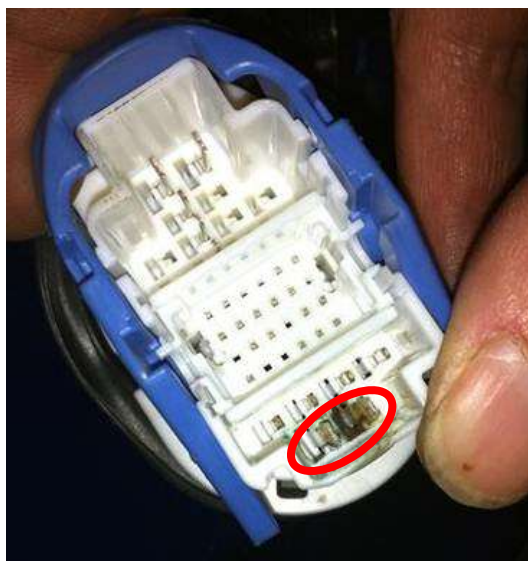
Door Harness side

(Sample photos of terminals with electric corrosion)

- If there is any corrosion found at the terminals, go to next step.
- If there is no corrosion found at the terminals, this Service Information is not applicable. Troubleshoot it according to the normal procedure in the Workshop Manual.
