Service Information

Category T	Repair Guidance	Ref. No. R082/13	Page 1 of 7
Coverage <input type="checkbox"/> Distributor only <input checked="" type="checkbox"/> Please inform your dealers		Date Issued October 15, 2013	
Please convey this information to your <input type="checkbox"/> Director <input checked="" type="checkbox"/> General Manager <input checked="" type="checkbox"/> Warranty Dept. <input checked="" type="checkbox"/> Parts Dept. <input checked="" type="checkbox"/> Training Dept. <input checked="" type="checkbox"/> Field Rep.		Date Revised	
Applicable Model CX-5(KE)		Applicable Countries or Specifications UK and Ireland

Subject: Electrical System Malfunction(s) in connection with failure of C-15 Connector

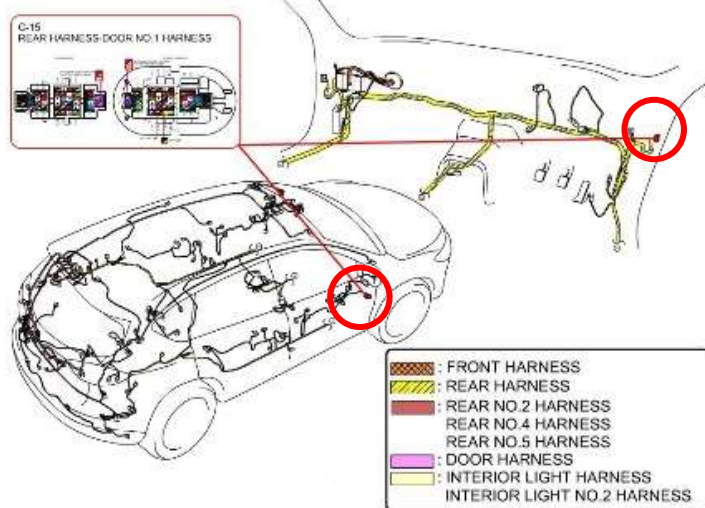
C-15 Connector

This concern is caused by corroded terminals of the C-15 connector due to water intrusion into the front door. At low ambient temperature, the door harness gets hardened. With this condition, if the door is fully opened, it may create a gap between the front door and the door harness grommet allowing water adhered to the front door to enter through the gap.

→ If there is any corrosion at the C-15 connector, replace the door harness and repair the rear harness according to the following repair procedure.

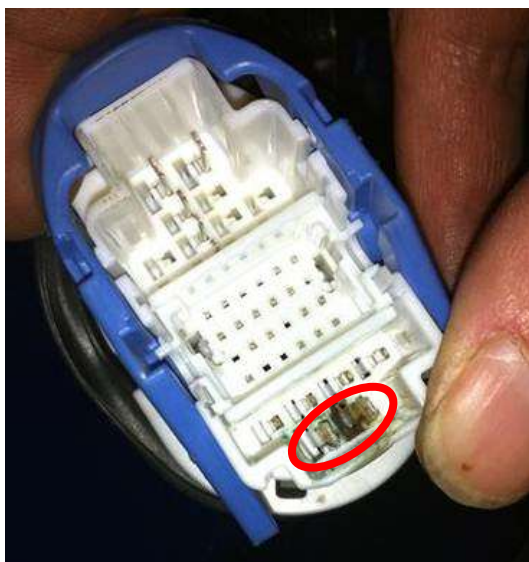
Door Harness side

(Sample photos of terminals with electric corrosion)

- If there is any corrosion found at the terminals, go to next step.
 - If there is no corrosion found at the terminals, this Service Information is not applicable. Troubleshoot it according to the normal procedure in the Workshop Manual.
4. Remove the driver-side front side trim according to the instructions in the Workshop Manual "**FRONT SIDE TRIM REMOVAL/INSTALLATION**".
 5. Pull out the C-15 connector out of the front pillar to inside the cabin.
