Subject: NEW MODEL SERVICE CAUTIONS	Bulletin No: 00-002/12
	Last Issued: 04/03/2012

BULLETIN NOTE

2013 CX-5

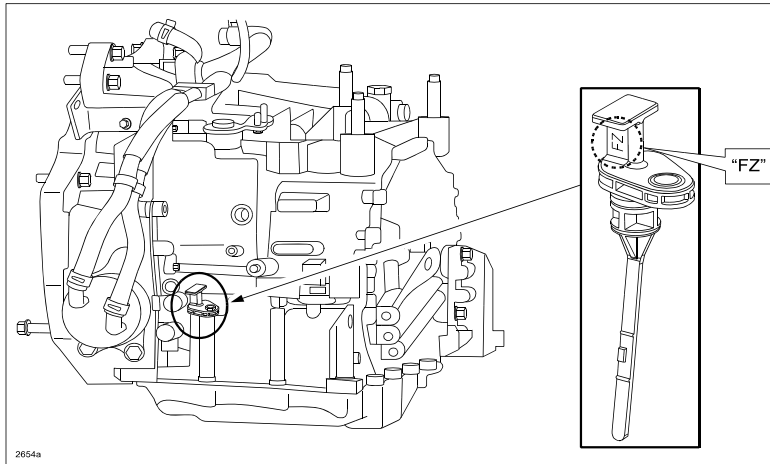
Only use "Automatic Transmission Fluid (ATF) FZ" for SKYACTIV-DRIVE. "ATF-FZ" is a low viscosity formula with less friction for better fuel economy. If an ATF other than "ATF-FZ" is used in the SKYACTIV-DRIVE ATX, the performance and reliability cannot be guaranteed. Any resulting damage will not be covered by warranty.

NOTE: ATF-FZ is colored blue, for easy identification. For ATX that requires ATF-FZ, "FZ" is marked on the dipstick as shown below.

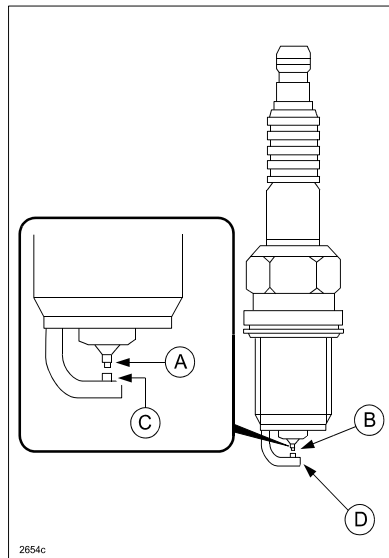
Only use the designated spark plugs for the SKYACTIV-G engine.

In order to achieve optimum ignition performance, SKYACTIV-G spark plugs use iridium (A) on an extremely thin center electrode (B) and platinum (C) on the ground electrode (D). Using general nickel or iridium plugs for the SKYACTIV-G engine could result in engine knocking, MIL illumination and/or poor driveability.
