Service Information

Category S	Repair Guidance	Ref. No. R027/13B	Page 1 of 7
Coverage <input type="checkbox"/> Distributor only <input checked="" type="checkbox"/> Please inform your dealers		Date Issued April 4, 2013	
Please convey this information to your <input type="checkbox"/> Director <input checked="" type="checkbox"/> General Manager <input checked="" type="checkbox"/> Warranty Dept. <input checked="" type="checkbox"/> Parts Dept. <input checked="" type="checkbox"/> Training Dept. <input checked="" type="checkbox"/> Field Rep.		Date Revised February 21, 2014	
Applicable Model CX-5 (KE)		Applicable Countries or Specifications Worldwide

Subject: Rattle noise from front door window glass

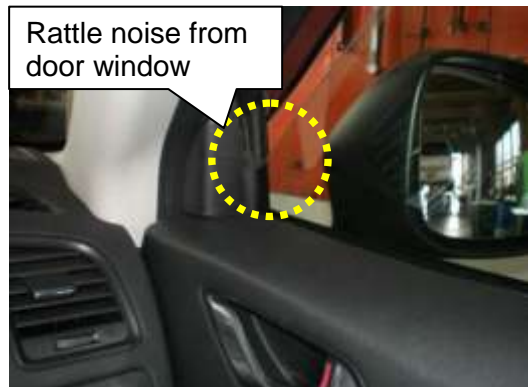
When driving a vehicle with the front door window glass partially opened for about 1 to 10 cm from the closed position, the door window glass causes a rattle noise.

The holding force of glass run channel is not sufficient.

The shape of glass run channel has been changed to increase the holding force.
