# Service Information

Category <b>S</b>	<b>Repair Guidance</b>	Ref. No. R017/12E	Page 1 of 5
Coverage <input type="checkbox"/> Distributor only <input checked="" type="checkbox"/> Please inform your dealers		Date Issued February 23, 2012	
Please convey this information to your <input type="checkbox"/> Director <input checked="" type="checkbox"/> General Manager <input checked="" type="checkbox"/> Warranty Dept. <input checked="" type="checkbox"/> Parts Dept. <input checked="" type="checkbox"/> Training Dept. <input checked="" type="checkbox"/> Field Rep.		Date Revised <b>December 13, 2013</b>	
Applicable Model  CX-5 (KE)	Applicable Countries or Specifications  Worldwide

**Subject: Rattle noise from instrumental panel and/or creak noise from A-pillar when driving on rough roads or over bumps**

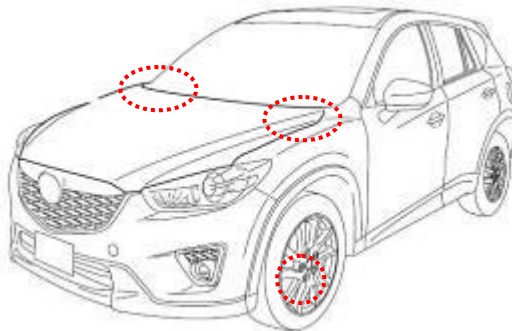
When driving on rough roads or over bumps, some vehicles may exhibit a rattle noise from the front of the instrumental panel and/or a creak noise from the bottom of the A-pillar.

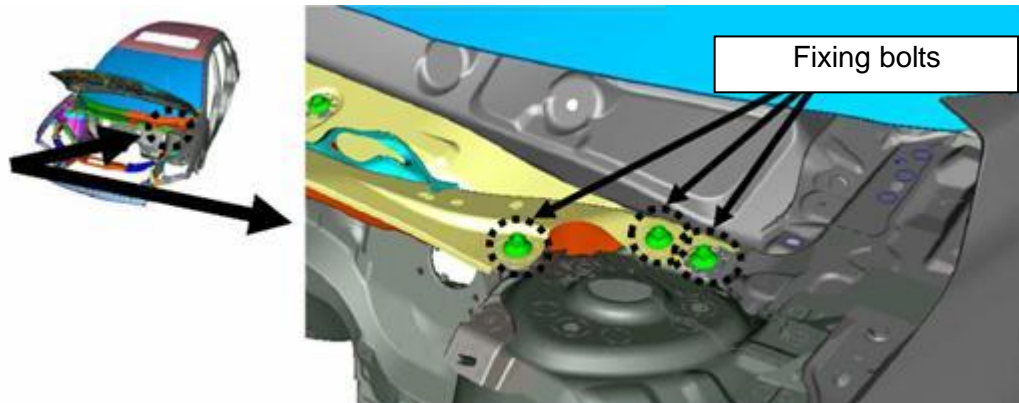
### <RATTLE NOISE>

Low torque of cowl panel fixing bolts.

1. Remove the cowl grille according to Workshop Manual "COWL GRILLE REMOVAL / INSTALLATION".
2. Retighten the cowl panel fixing bolts (both sides, total 6pcs).  
※Tightening torque: 22 - 30 Nm

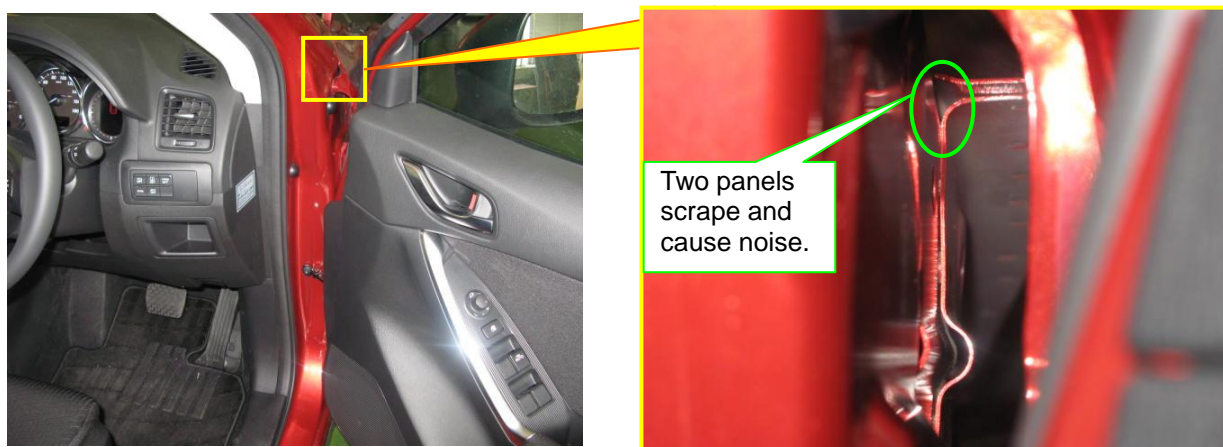
<CREAK NOISE>

Two panels jointing at the bottom of the A-pillar scrape each other causing the noise.

Enlarge the clearance between two panels at the problem side using an appropriate tool (a covered flat-blade screwdriver).

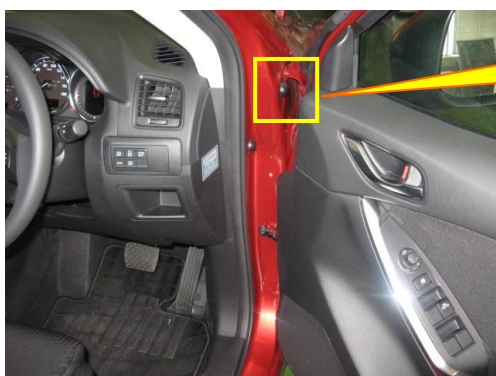
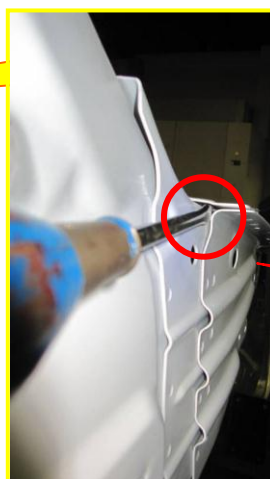
Produce clearance between two panels here.

NOTE: In the picture, the front fender is removed to give a better view of the problem area. During the actual work, the removal is not necessary.
