Service Information

Category S	Repair Guidance	Ref. No. R085/13	Page 1 of 3
Coverage <input type="checkbox"/> Distributor only <input checked="" type="checkbox"/> Please inform your dealers		Date Issued October 23, 2013	
Please convey this information to your <input type="checkbox"/> Director <input checked="" type="checkbox"/> General Manager <input checked="" type="checkbox"/> Warranty Dept. <input checked="" type="checkbox"/> Parts Dept. <input checked="" type="checkbox"/> Training Dept. <input checked="" type="checkbox"/> Field Rep.		Date Revised	
Applicable Model CX-5 (KE)		Applicable Countries or Specifications Worldwide

Subject: Rattling Noise from Rear Center Seat Back when driving on rough road

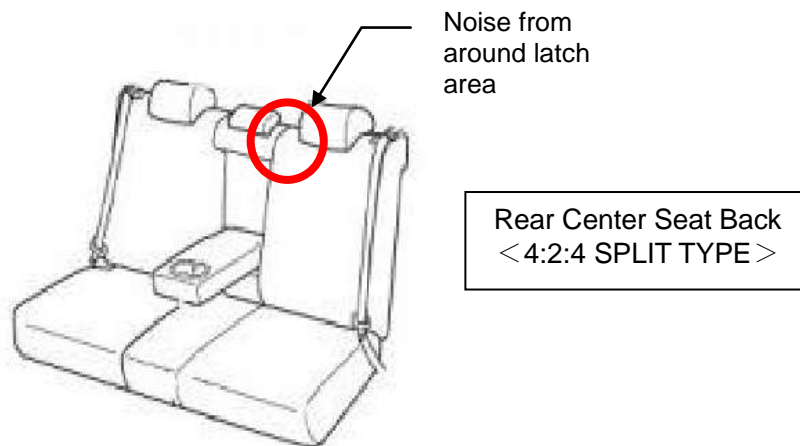
When driving on rough roads, some vehicles may exhibit a rattling noise which is heard around the latch of the rear center seat back.

The stopper rubber in the latch of the rear center seat back may come off the fixing bracket. Due to this, the fixing bracket contacts the striker, causing a noise when driving on rough road.

Shapes of the stopper rubber and the fixing bracket have been changed to secure installation of the stopper rubber.

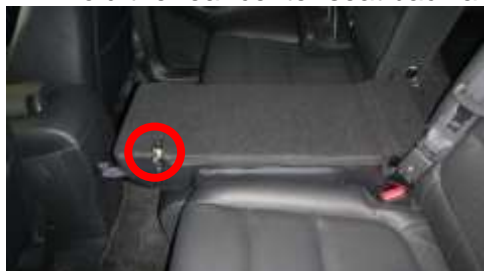
1. Fold the rear center seat back and the arm rest as shown in figure.

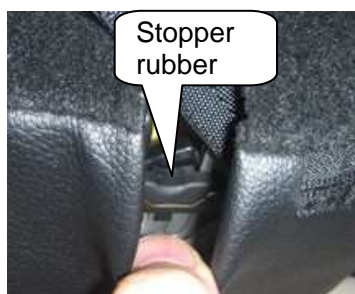
2. Check installation condition of the stopper rubber in the fixing bracket (position circled in red in the above figure). If the stopper rubber falls down or comes off the fixing bracket, replace it with a new one established as a service part.

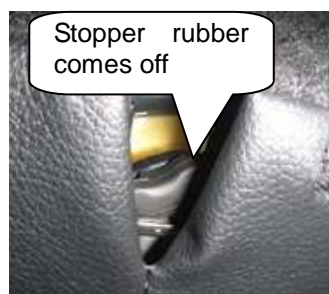
Rubber is not correctly fit
