# Service Information

Category <b>T</b>	<b>Technical</b>	Ref. No. E010/14	Page 1 of 3
Coverage <input type="checkbox"/> Distributor only <input checked="" type="checkbox"/> Please inform your dealers		Date Issued May 12, 2014	
Please convey this information to your <input type="checkbox"/> Director <input checked="" type="checkbox"/> General Manager <input checked="" type="checkbox"/> Warranty Dept. <input checked="" type="checkbox"/> Parts Dept. <input checked="" type="checkbox"/> Training Dept. <input checked="" type="checkbox"/> Field Rep.		Date Revised	
Applicable Model  Mazda3(BM), Mazda6 (GJ) and CX-5(KE)		Applicable Countries or Specifications  Worldwide

## Subject: Multiple Electrical Malfunctions after replacing Front Fender Stay by body repair

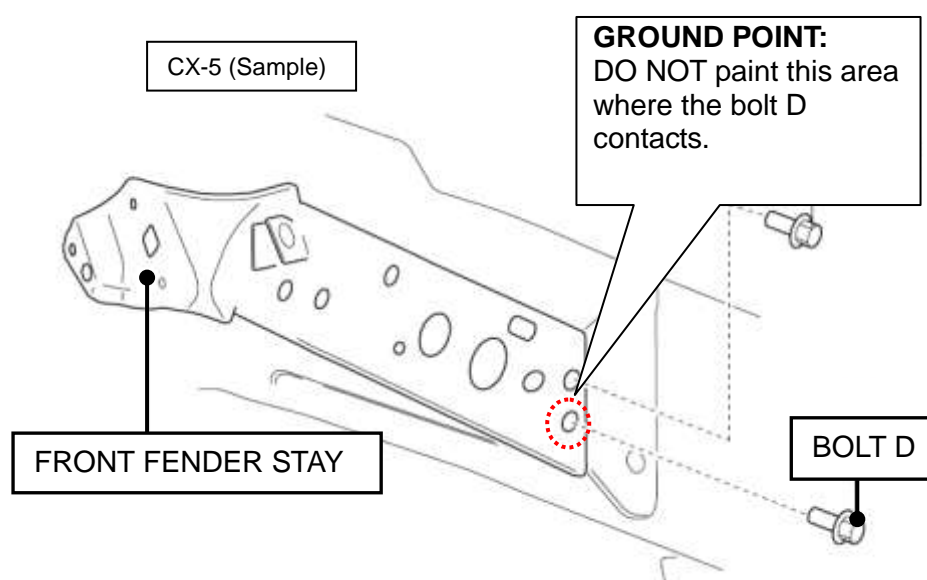
At all four vehicles the front fender stay was replaced by body repair previously, and inspection found that the newly installed fender stay was painted at the area where the bolt D is seated, causing poor ground of the front harness.

Reinstallation of the front fender stay after sanding off the paint at the bolt D contact area solved all the problems.

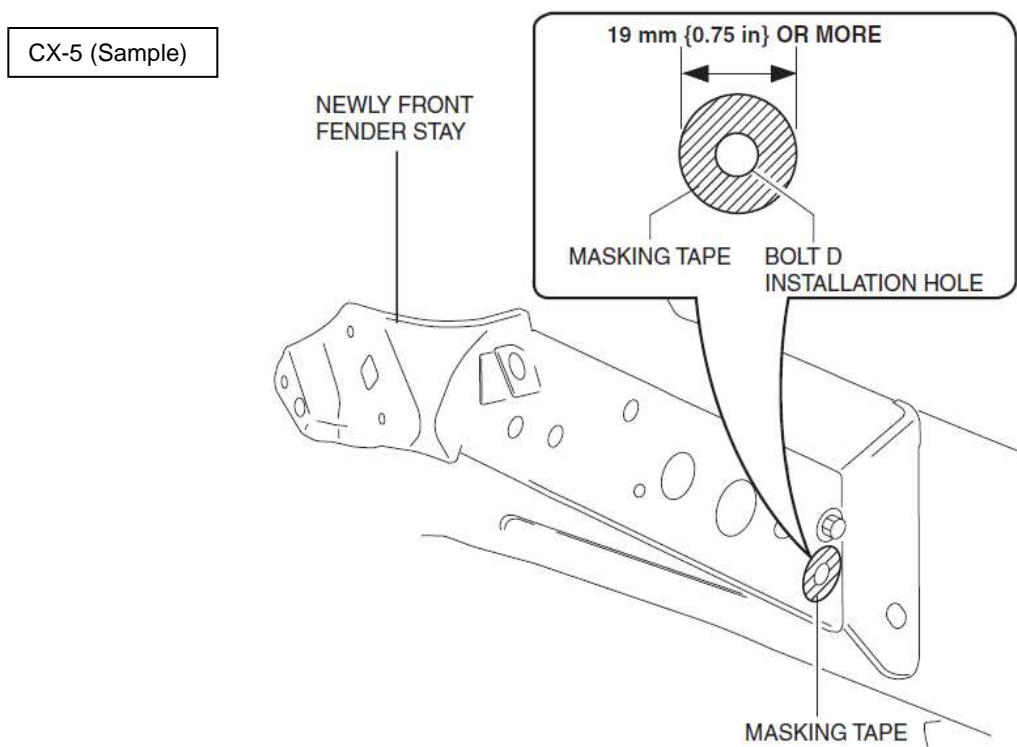
If the bolt D contact area is painted when the front fender stay is newly replaced, it could cause a malfunction in the PCM. Before painting a newly replaced part, protect the bolt D contact areas with masking tape as shown in the figure.

After installing the bolt D, apply touch-up paint to the exposed base material area of the front fender stay.
