Service Information

Category T	Repair Guidance	Ref. No. R040/14	Page 1 of 2
Coverage <input type="checkbox"/> Distributor only <input checked="" type="checkbox"/> Please inform your dealers		Date Issued May 14, 2014	
Please convey this information to your <input type="checkbox"/> Director <input checked="" type="checkbox"/> General Manager <input checked="" type="checkbox"/> Warranty Dept. <input checked="" type="checkbox"/> Parts Dept. <input checked="" type="checkbox"/> Training Dept. <input checked="" type="checkbox"/> Field Rep.		Date Revised	
Mazda6(GJ) with Parking Sensor System and without Rear View Camera		Applicable Countries or Specifications Worldwide

Subject: Audio Screen turns blue when shift lever is shifted to “R”

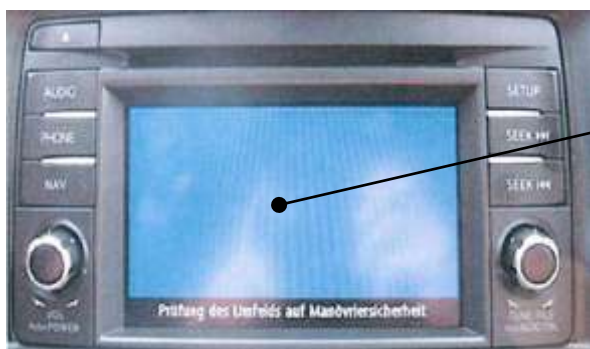
Some vehicles may experience a condition that the audio screen turns to “blue-screen” when the shift lever is shifted to “R”. The parking sensor system works normally by activating a beep sound, but the parking sensor indicator is not displayed on the audio screen because of the blue screen.

Screen turns blue when shifted to “R”.

If the steering wheel is turned immediately after engine start, the audio unit receives a signal (electrical noise caused by EPS motor) as if rear camera was equipped.

When you encounter a customer complaint on this concern, disconnect the rear view camera harness connector from the audio unit as follows.
