Service Information

Category P	Repair Guidance	Ref. No. R105/13	Page 1 of 2
Coverage <input type="checkbox"/> Distributor only <input checked="" type="checkbox"/> Please inform your dealers		Date Issued December 12 , 2013	
Please convey this information to your <input type="checkbox"/> Director <input checked="" type="checkbox"/> General Manager <input checked="" type="checkbox"/> Warranty Dept. <input checked="" type="checkbox"/> Parts Dept. <input checked="" type="checkbox"/> Training Dept. <input checked="" type="checkbox"/> Field Rep.		Date Revised	
Applicable Model Mazda6(GJ)		Applicable Countries or Specifications Europe

Subject: Front Brake Judder

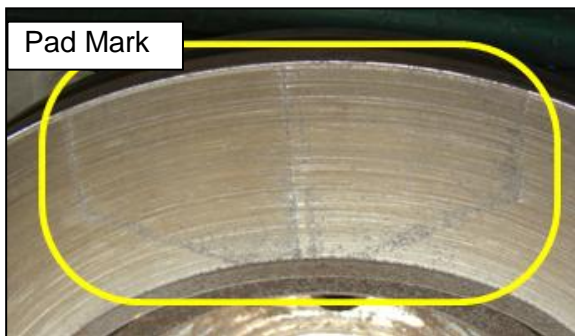
Initial pad mark

Both pictures show pad marks

- (1) Measure the lateral runout of front disc plate according to the Workshop Manual.
If it exceeds the limit, machine the disc plate using an on-the-car type lathe and adjust the disc thickness to within the limit.
- Front disc plate runout limit: 0.04mm (at the axial position of 10 mm from the disc plate edge)
 - Minimum front disc plate thickness after machining using a brake lathe on-vehicle: 26.8 mm
- (2) Replace the front brake pads with modified ones according to the Workshop Manual procedure.

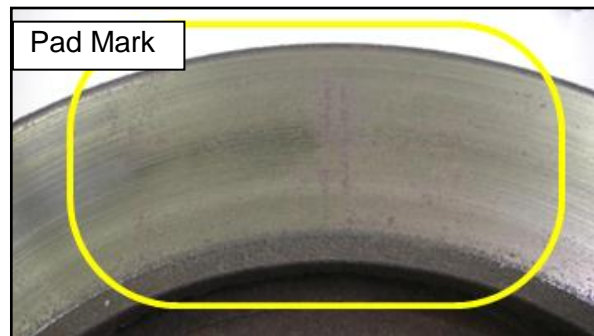
After being exposed to excessive heat generation, pad mark changes in its color.
