Service Information

| Category S | Repair Guidance | Ref. No. R010/14A | Page 1 of 2 |
| Applicable Model Mazda6 (GJ) | | Applicable Countries or Specifications Worldwide | |

Subject: Bonnet vibrates when driving at more than 110 Km/h

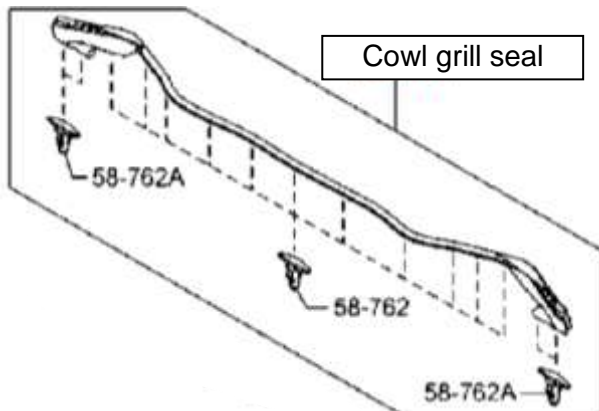
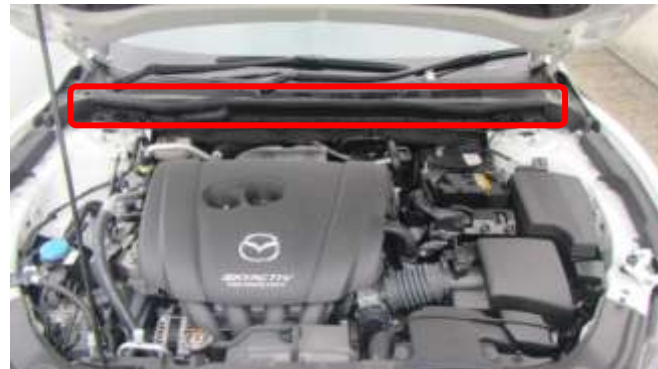
The preload forces of the cowl grill seal may be insufficient which can also affect the bonnet vibration adversely.

Note: The cowl grill seal is attached to the cowl grill with clips.

Replace the cowl grill seal with a modified one with increased preload force.
