Service Information

Category T	Repair Guidance	Ref. No. R090/13	Page 1 of 3
Coverage <input type="checkbox"/> Distributor only <input checked="" type="checkbox"/> Please inform your dealers		Date Issued November 7, 2013	
Please convey this information to your <input type="checkbox"/> Director <input checked="" type="checkbox"/> General Manager <input checked="" type="checkbox"/> Warranty Dept. <input checked="" type="checkbox"/> Parts Dept. <input checked="" type="checkbox"/> Training Dept. <input checked="" type="checkbox"/> Field Rep.		Date Revised	
Applicable Model Mazda6 (GJ) Sedan		Applicable Countries or Specifications Europe, Russia

Subject: Water Entry into Trunk Lid Light at high pressure car washing

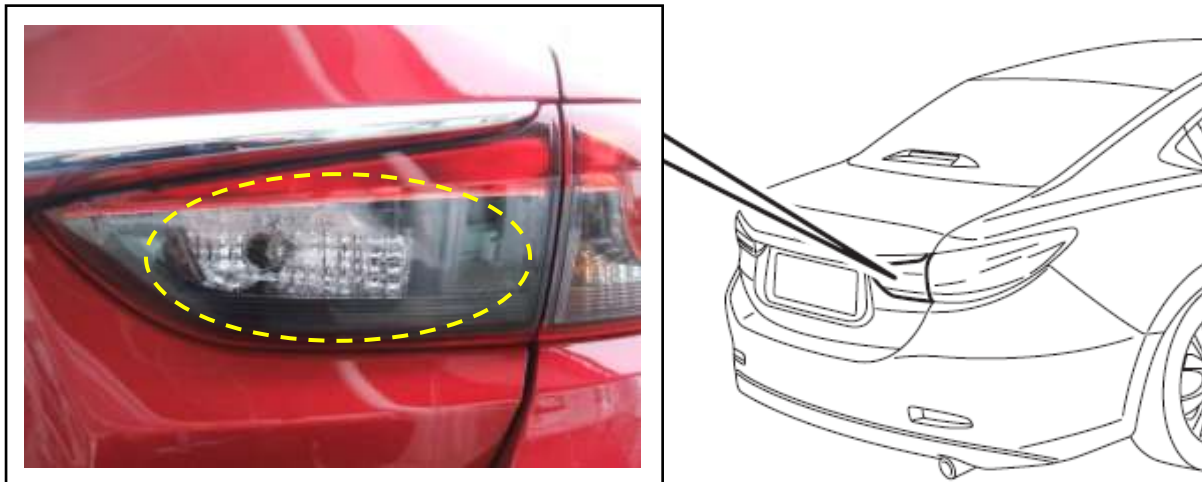
Some vehicles may exhibit a condition that water enters into the trunk lid light while washing the vehicle with a high pressure cleaner.

Water enters through the trunk lid light gasket and the body panel due to a lack of sealing performance against the usage of high pressure cleaner.

Replace the trunk lid light with a new one. At this time, remove and discard the gasket attached to the new trunk lid light and use a modified gasket newly established as a service part instead.
