Service Information

Category D	Technical	Ref. No. E002/14	Page 1 of 3
Coverage <input type="checkbox"/> Distributor only <input checked="" type="checkbox"/> Please inform your dealers		Date Issued January 7, 2014	
Please convey this information to your <input type="checkbox"/> Director <input checked="" type="checkbox"/> General Manager <input checked="" type="checkbox"/> Warranty Dept. <input checked="" type="checkbox"/> Parts Dept. <input checked="" type="checkbox"/> Training Dept. <input checked="" type="checkbox"/> Field Rep.		Date Revised	
Applicable Model All models with SKYACTIV-D 2.2		Applicable Countries or Specifications Europe, ADR

Subject: Service Caution for Oil Pan Removal and Installation

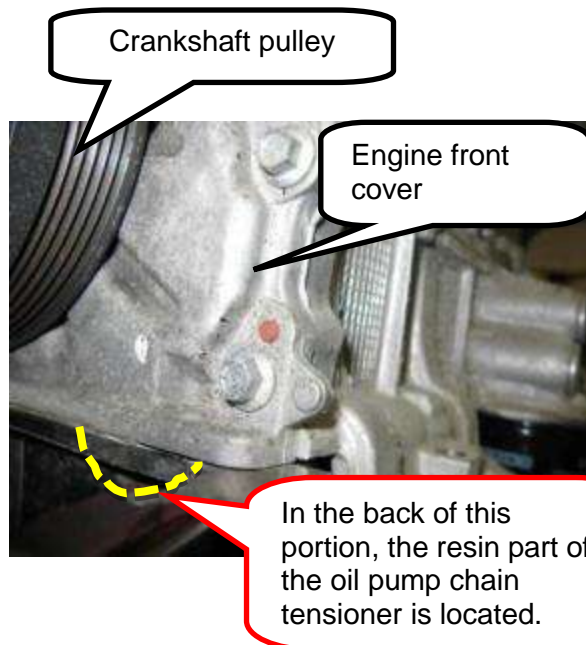
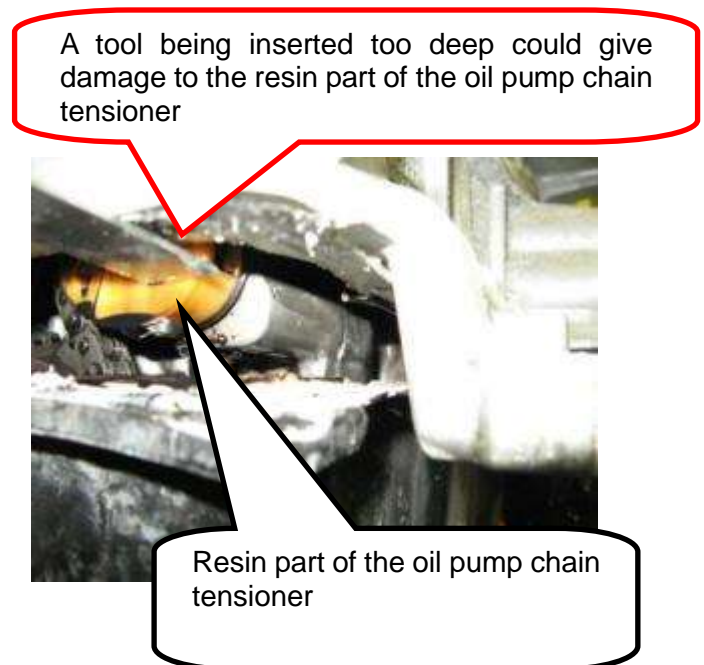
When separating the oil pan from the engine front cover using a cutting tool, DO NOT insert the tool deeper than 20mm, or it could damage the resin part of the oil pump chain tensioner. Refer to the location of the resin part of oil pump chain tensioner in the below photos and the sample photos of the damaged resin on the next page.

Note: In order to prevent inserting the cutting tool too deep, put a masking tape at the mark of 20mm from the edge of the tool as shown in the picture.

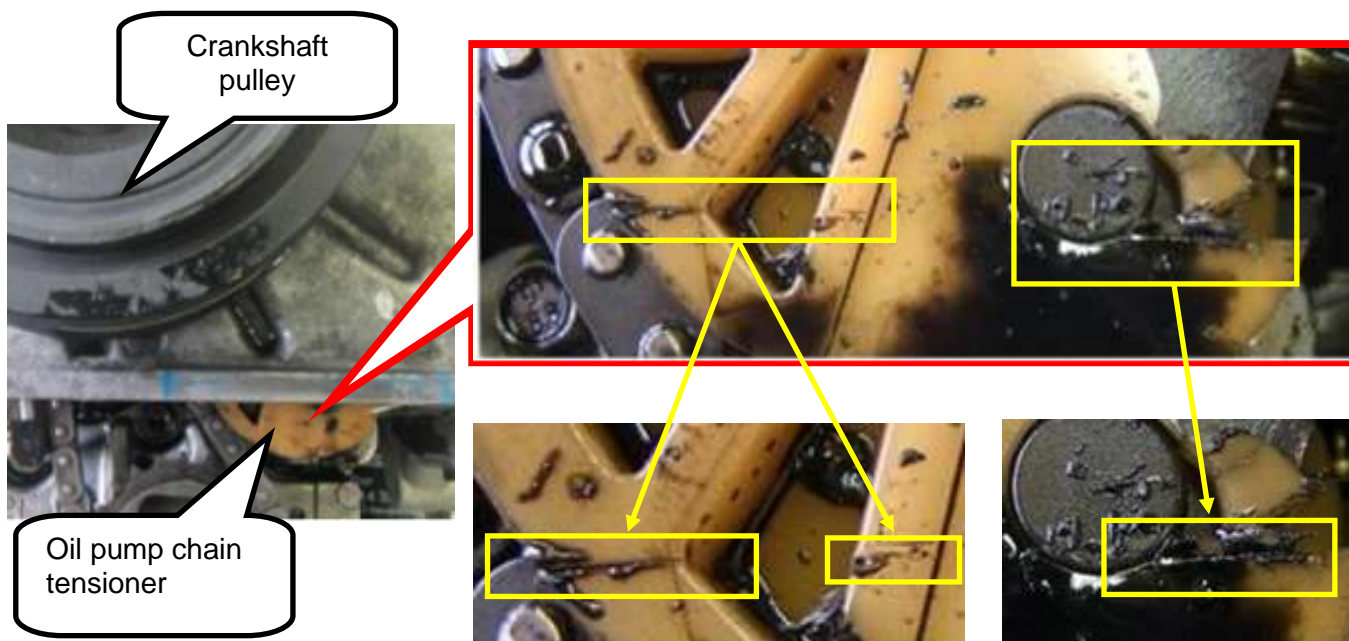
Samples of damaged resin caused by the cutting tool inserted too deep.

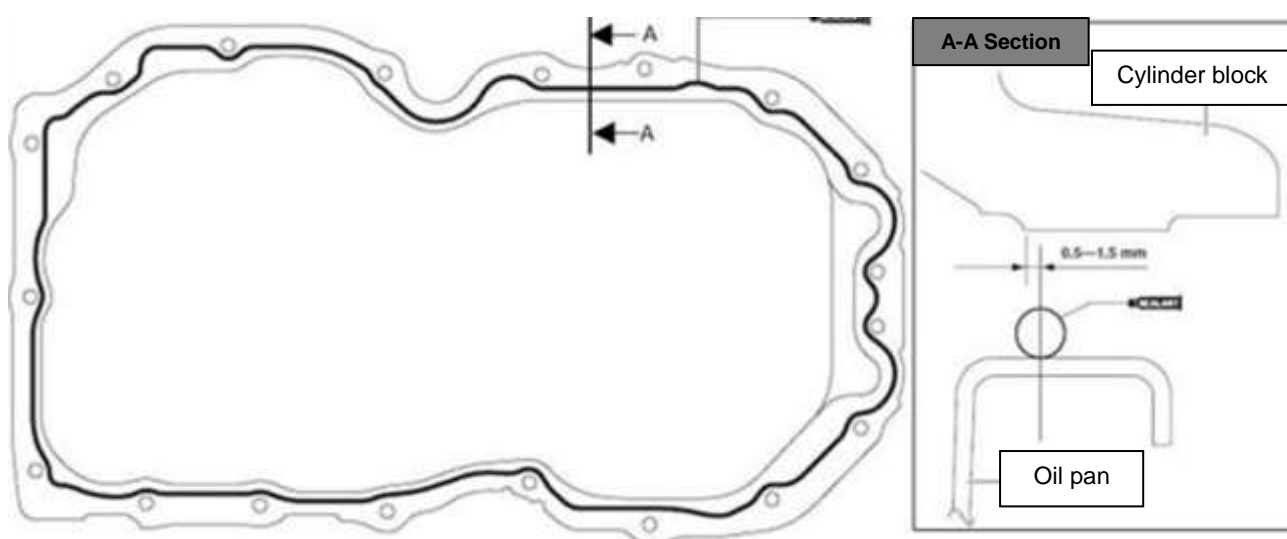
Oil pan

When installing the oil pan, apply silicone sealant properly on both sides, the oil pan and the cylinder block as shown in the below pictures. If the silicone sealant application position is incorrect or if there is any break in the application track, engine oil leakage will occur due to poor sealing. It takes an hour to harden the silicone sealant completely. Therefore, refill the engine oil after more than 1 hour upon sealant application.

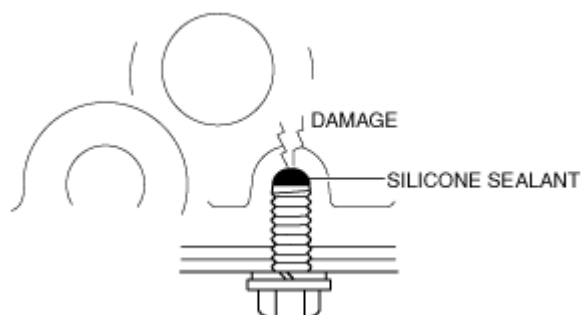
Note: Remove any silicone sealant which oozes out into an oil pan installation bolt hole.
If silicone sealant penetrates an oil pan installation bolt hole, the cylinder block could become damaged.
