Service Information

| Category T | Repair Guidance | Ref. No. R084/13A | Page 1 of 12 |
| Applicable Model CX-5 (KE) Mazda6(GJ) with TomTom NB-1 Navigation | | Applicable Countries or Specifications Europe | |

Subject: TomTom NB-1 NAVIGATION Concerns Solved by Software update

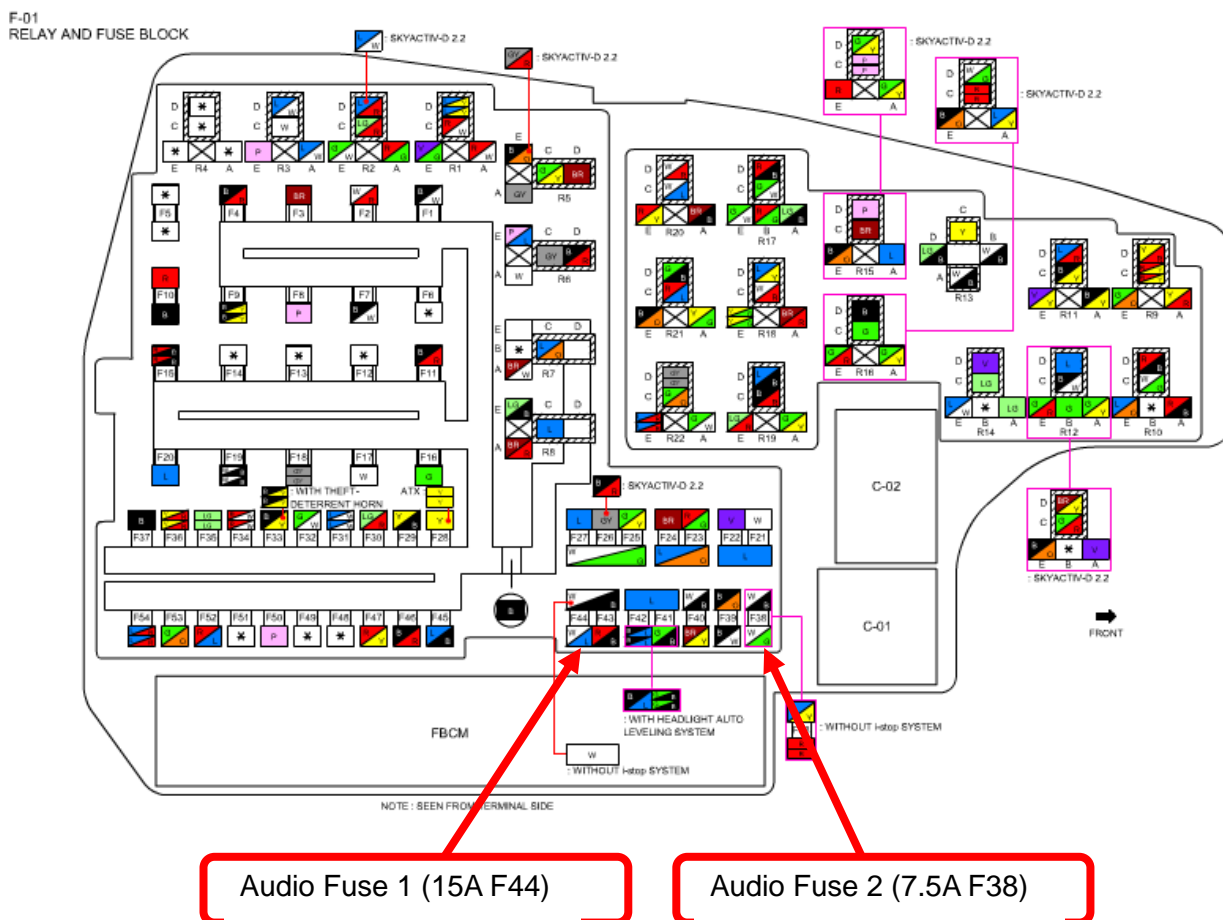
Supplemental document 5: System Re-boot

For symptoms like “Navigation is freezing while operating or does not start”, “monochrome display (colours missing) and/or GPS signal missing”, it often helps to switch IG off and remove the Audio Fuse 1 (15A F44) and Audio Fuse 2 (7.5A F38) for about 5 minutes. After re-inserting both fuses and switching IG on, TomTom navigation box will reboot completely including reading software from SD-card (when you push the NAV button you will see a black screen with TomTom logo after short time).
