2014 Mazda3, 2014 Mazda6 WITH I-ELOOP

Q-85 / T-110 BATTERY REPLACEMENT

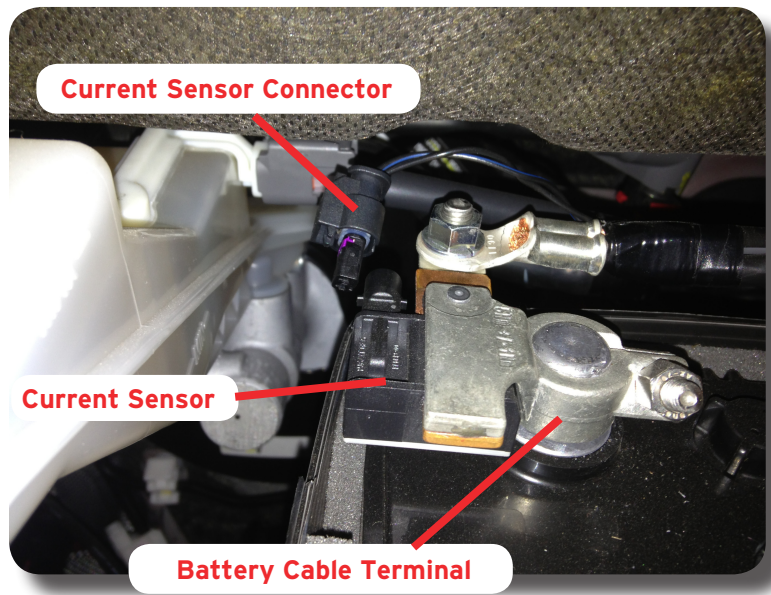
4	<p>Disconnect the negative battery cable:</p> <ul style="list-style-type: none"> a. Switch the ignition OFF. b. Disconnect the current sensor connector. c. Disconnect the negative battery cable terminal.
---	--

5	<p>Connect the negative battery cable:</p> <ul style="list-style-type: none"> a. Connect the negative battery cable terminal. b. Connect the current sensor connector.
---	--
