Service Information

Category M	Repair Guidance	Ref. No. R044/14	Page 1 of 5
Coverage <input type="checkbox"/> Distributor only <input checked="" type="checkbox"/> Please inform your dealers		Date Issued May 28, 2014	
Please convey this information to your <input type="checkbox"/> Director <input checked="" type="checkbox"/> General Manager <input checked="" type="checkbox"/> Warranty Dept. <input checked="" type="checkbox"/> Parts Dept. <input checked="" type="checkbox"/> Training Dept. <input checked="" type="checkbox"/> Field Rep.		Date Revised	
Applicable Model CX-5 (KE) with 4WD		Applicable Countries or Specifications Europe spec

Subject: Chattering / Rattling Noise from Rear of the Vehicle (Coupling Unit).

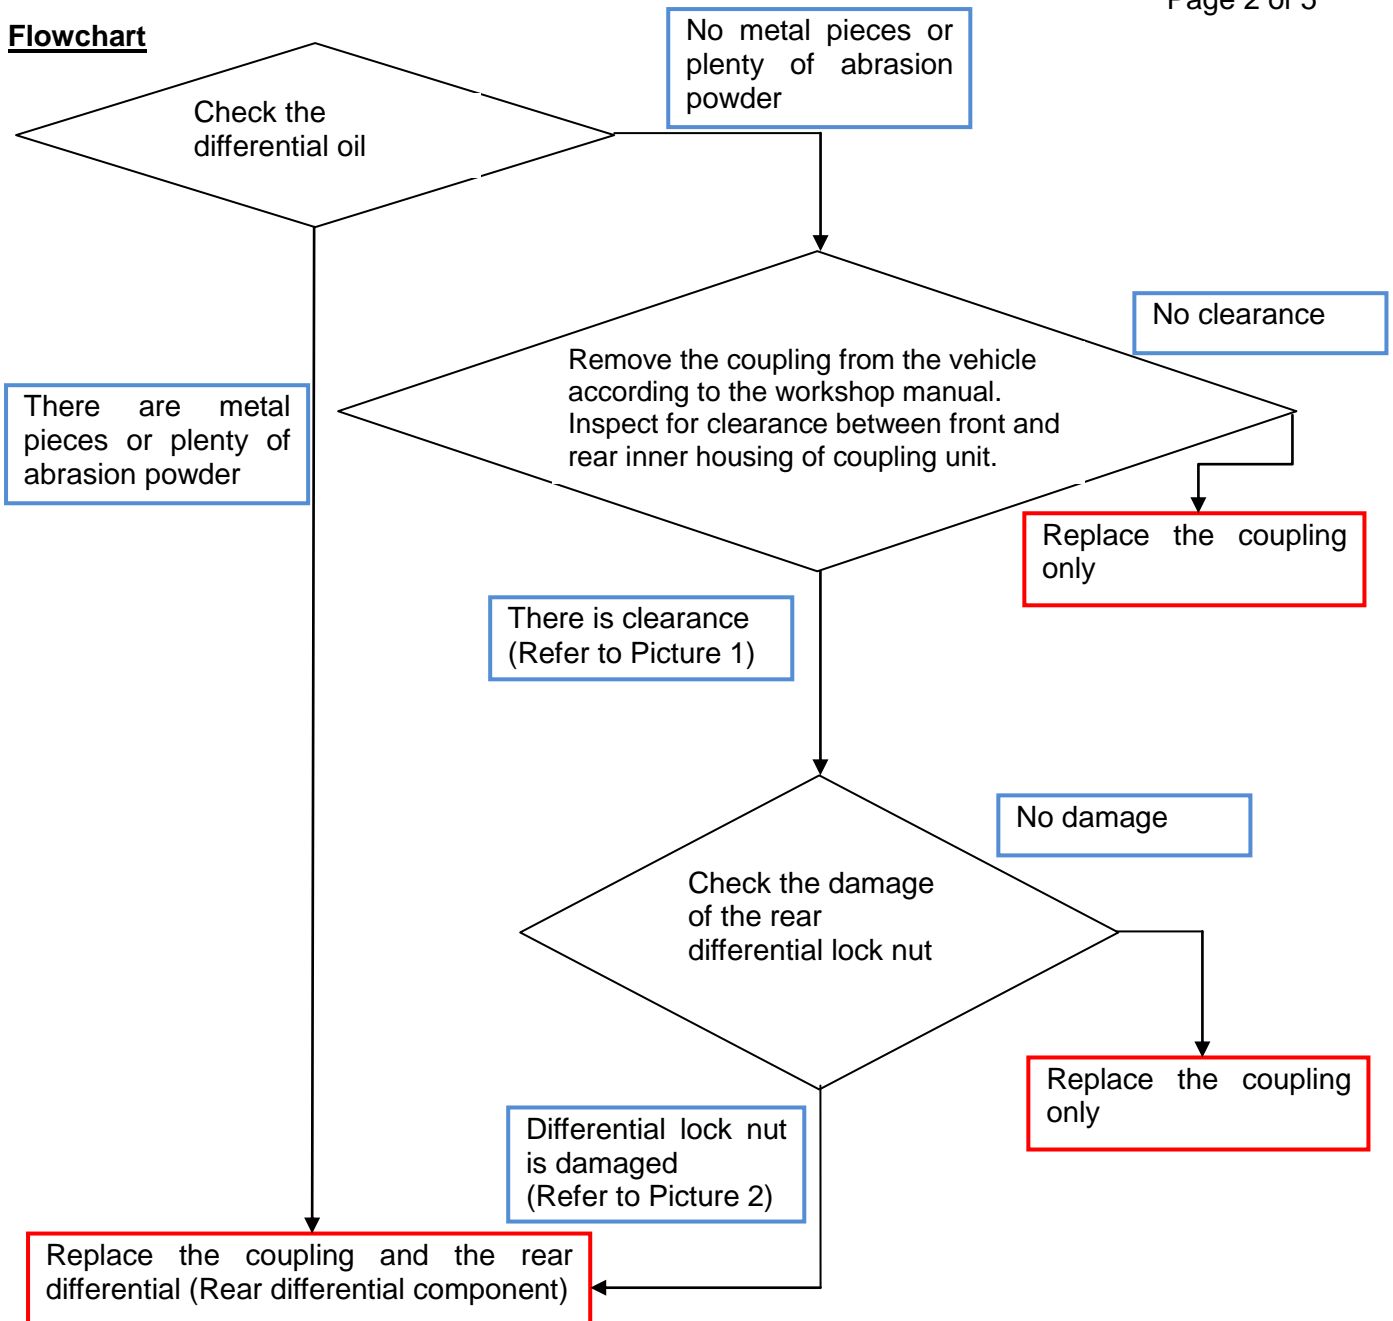
Flowchart

1. Lift up the vehicle.
2. Verify if the noise is heard from the coupling unit when the vehicle speed is approximately 5 to 10 km/h by the speedometer reading.
Note: Refer to the attached video of noise sample.
3. If the noise is present, drain the differential oil then verify if metal pieces or a plenty of abrasion powder are present in the oil.
Refer to the flowchart on the next page for proper diagnosis.

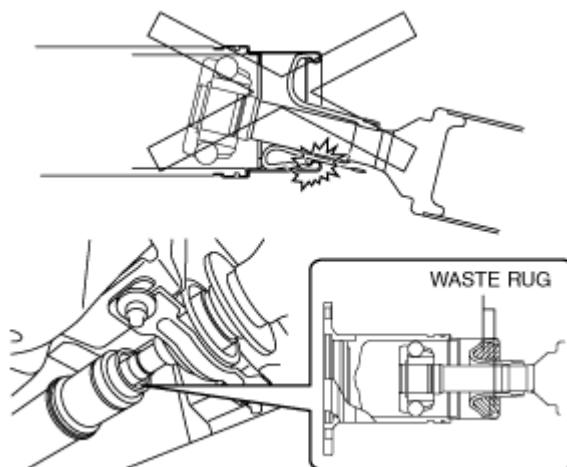
CAUTION 1:

If the constant velocity joint angle is excessive during propeller shaft removal/installation, the constant velocity joint boot may be damaged when contacting the metallic cover. Protect the constant velocity joint boot by inserting a shop rag between the boot and the metallic cover.

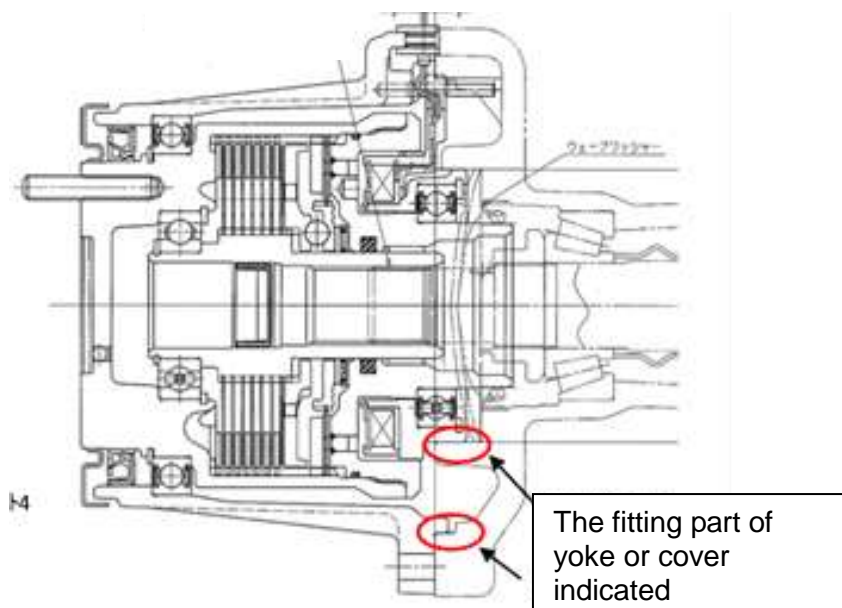
CAUTION 2: Coupling Unit Installation Note

During the assembly process at plant, the housing of the coupling unit may have been installed incorrectly (diagonally) to the housing of the rear differential. In this case, sliding resistance of the bearing in the coupling unit may increase causing the noise.

1. Install the coupling unit straight to the rear differential in order to prevent any damage by jamming (inclined installation) to the fitting part of yoke or cover indicated in red circle.
