# Service Information

Category <b>N</b>	<b>Repair Guidance</b>	Ref. No. R067/13 <b>B</b>	Page 1 of 6
Coverage <input type="checkbox"/> Distributor only <input checked="" type="checkbox"/> Please inform your dealers		Date Issued August 28, 2013	
Please convey this information to your <input type="checkbox"/> Director <input checked="" type="checkbox"/> General Manager <input checked="" type="checkbox"/> Warranty Dept. <input checked="" type="checkbox"/> Parts Dept. <input checked="" type="checkbox"/> Training Dept. <input checked="" type="checkbox"/> Field Rep.		Date Revised <b>June 12, 2014</b>	
Applicable Model  Mazda6(GJ), CX-5(KE), Mazda3(BM)		Applicable Countries or Specifications  Worldwide

**Subject: Unusual noise when vehicle is started with steering wheel fully turned to driver-side**

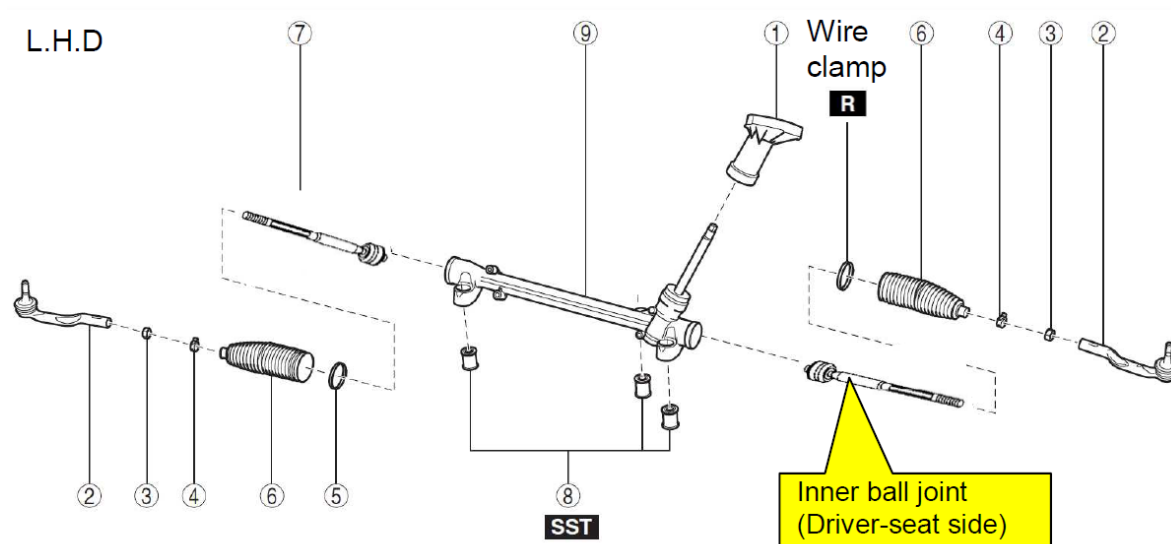
An edge of the inner ball joint at the driver-side may get stuck with the steering gear housing, causing a stick-slip noise.

1. The shape of the inner ball joint edge has been changed.
2. Grease has been applied to the inner ball joint edge.
