Service Information

Mazda Motor Corporation

Category T	Repair Guidance	Ref. No. R079/13A	Page 1 of 4
Coverage <input type="checkbox"/> Distributor only <input checked="" type="checkbox"/> Please inform your dealers		Date Issued October 10, 2013	
Please convey this information to your <input type="checkbox"/> Director <input checked="" type="checkbox"/> General Manager <input checked="" type="checkbox"/> Warranty Dept. <input checked="" type="checkbox"/> Parts Dept. <input checked="" type="checkbox"/> Training Dept. <input checked="" type="checkbox"/> Field Rep.		Date Revised June 12, 2014	
Applicable Model Mazda6 (GJ) with MRCC	Applicable Countries or Specifications Worldwide

Subject: “FOW/SBS Inspection Required” indication in instrument cluster is illuminated. (DTC: C1A67:78)

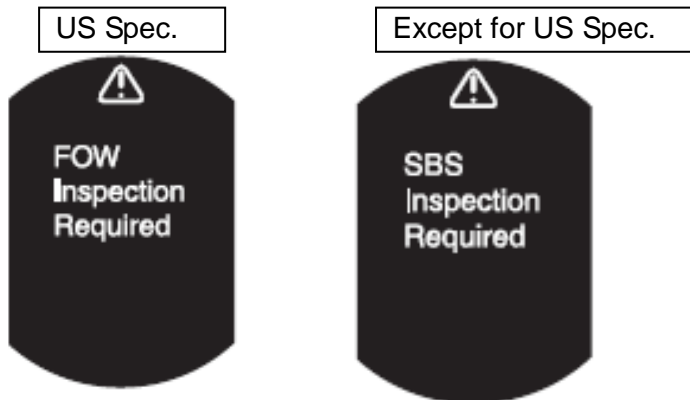
Some vehicles may exhibit the stopping of MRCC operation if driving without stopping for a long time and no obstacle which MRCC can detect.

Additionally, “FOW/SBS inspection required” is displayed in instrument cluster and DTC C1A67:78 is set due to misjudgment.

C1A67:78 Radar sensor axis is deviated

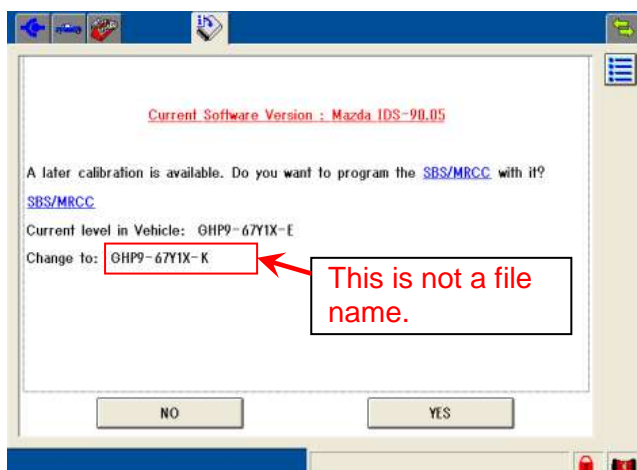
Figure 1: Subject for VCM reprogramming

- If the Figure 1 is displayed, the VCM is before the latest calibration. Click “YES” and follow the M-MDS instructions to reprogram the VCM.
- If the Figure 2 is displayed, the VCM is already the latest calibration. This Service Information does not apply and refer to Workshop Manual for troubleshooting and repair.
