Service Information

Category S	Repair Guidance	Ref. No. R001/14 B	Page 1 of 4
Coverage <input type="checkbox"/> Distributor only <input checked="" type="checkbox"/> Please inform your dealers		Date Issued January 6, 2014	
Please convey this information to your <input type="checkbox"/> Director <input checked="" type="checkbox"/> General Manager <input checked="" type="checkbox"/> Warranty Dept. <input checked="" type="checkbox"/> Parts Dept. <input checked="" type="checkbox"/> Training Dept. <input checked="" type="checkbox"/> Field Rep.		Date Revised July 29, 2014	
Applicable Model Mazda3(BM)		Applicable Countries or Specifications Worldwide

Subject: Rattle noise from bottom of A-pillar

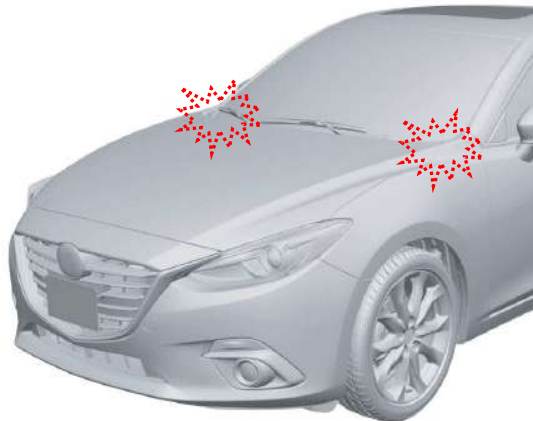
When driving on rough roads or over bumps, some vehicles may exhibit a rattle noise from the bottom of the A-pillar.

The cowl upper plate and/or dash upper panel interferes with the wiper bracket causing a noise.

When you encounter a customer complaint on this concern, create a clearance between the affected panels. (Between wiper bracket~Cowl upper plate and between wiper bracket~dash upper panel) by using the following procedure.
