Service Information

Category S	Repair Guidance	Ref. No. R038/14A	Page 1 of 4
Coverage <input type="checkbox"/> Distributor only <input checked="" type="checkbox"/> Please inform your dealers		Date Issued April 25, 2014	
Please convey this information to your <input type="checkbox"/> Director <input checked="" type="checkbox"/> General Manager <input checked="" type="checkbox"/> Warranty Dept. <input checked="" type="checkbox"/> Parts Dept. <input checked="" type="checkbox"/> Training Dept. <input checked="" type="checkbox"/> Field Rep.		Date Revised August 5, 2014	
Applicable Model Mazda3 (BM)		Applicable Countries or Specifications Worldwide

Subject: Side(s) of Rear Seat Cushion is loose

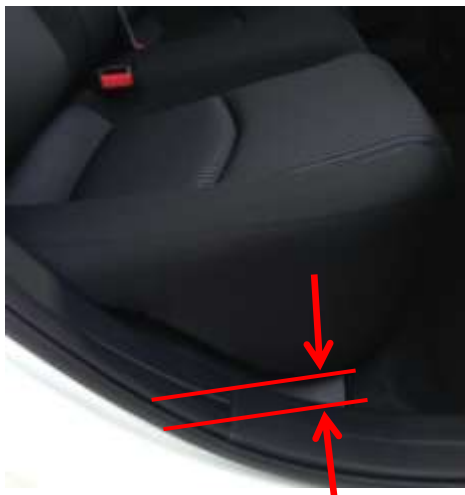
Looks floating above floor carpet

Due to product variation of the rear seat cushion, some may have a larger clearance between the cushion and the floor carpet.

When you receive a customer complaint on this concern, fix the both sides of rear seat cushion to the floor carpet by using Velcro tapes. Refer to the below procedure.

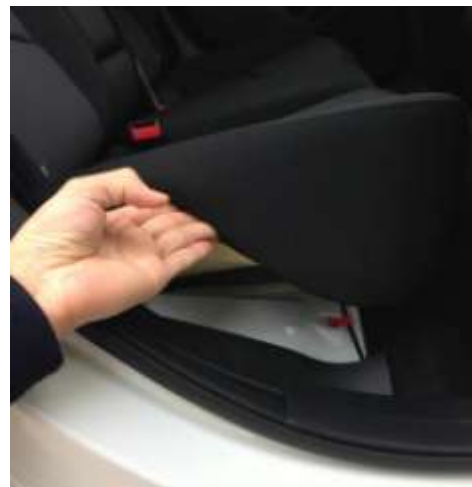
It wobbles when lifting by hand.
