Service Information

Category S	Repair Guidance	Ref. No. R044/12A	Page 1 of 8
Coverage <input type="checkbox"/> Distributor only <input checked="" type="checkbox"/> Please inform your dealers		Date Issued June 18, 2012	
Please convey this information to your <input type="checkbox"/> Director <input checked="" type="checkbox"/> General Manager <input checked="" type="checkbox"/> Warranty Dept. <input checked="" type="checkbox"/> Parts Dept. <input checked="" type="checkbox"/> Training Dept. <input checked="" type="checkbox"/> Field Rep.		Date Revised June 13, 2014	
Applicable Model CX-5 (KE)		Applicable Countries or Specifications Worldwide

Subject: Liftgate Opener Switch Not Operate

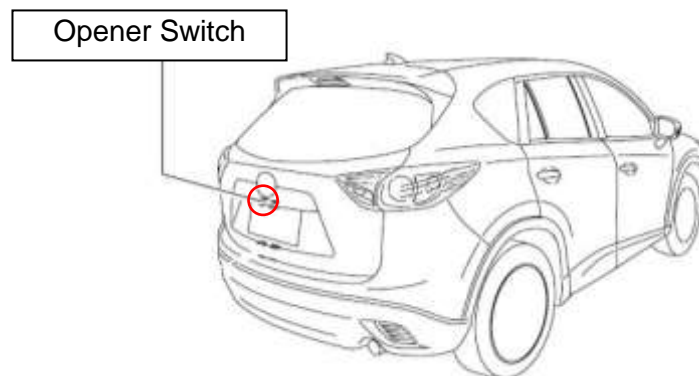
Some vehicles may exhibit that the liftgate does not open when the liftgate opener switch (hereafter called "opener switch") is pushed on.

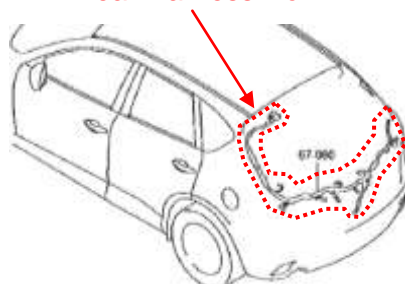
Illustration

Water-proof sheet

Rear Harness No.2

Water-proof protector

Use of the water-proof sheet has been discontinued; instead a water-proof protector has been installed to protect the opener switch.

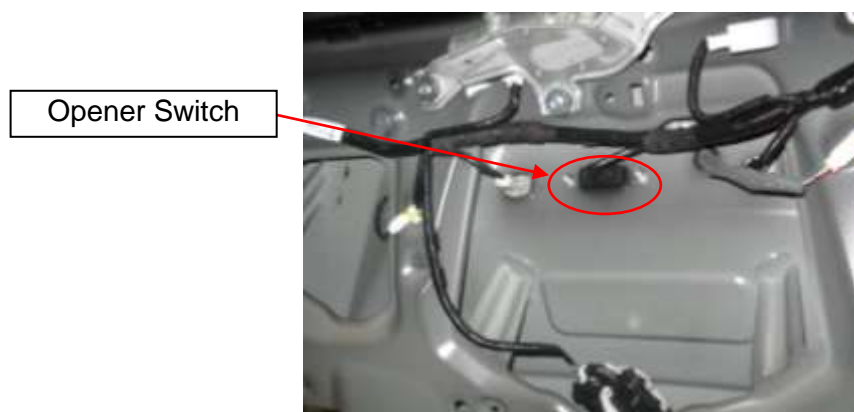
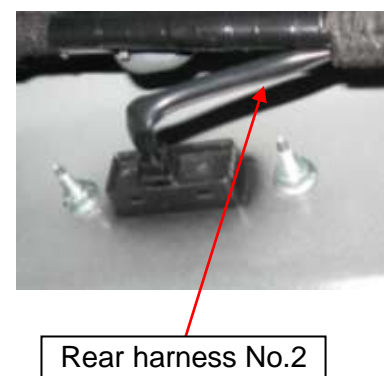
A. Inspection of Rust Occurrence at connector terminals (For all vehicles A, B and C)

1. Remove the liftgate trim. Refer to Workshop Manual [LIFTGATE LOWER TRIM INSTALLATION/REMOVAL].
2. Disconnect the connector from the opener switch and check for any water intrusion and any rust on the terminals in the connector at the opener switch and at the rear harness No.2.
