# Service Information

Category <b>K</b>	<b>Repair Guidance</b>	Ref. No. R062/14	Page 1 of 4
Coverage <input type="checkbox"/> Distributor only <input checked="" type="checkbox"/> Please inform your dealers		Date Issued August 4, 2014	
Please convey this information to your <input type="checkbox"/> Director <input checked="" type="checkbox"/> General Manager <input checked="" type="checkbox"/> Warranty Dept. <input checked="" type="checkbox"/> Parts Dept. <input checked="" type="checkbox"/> Training Dept. <input checked="" type="checkbox"/> Field Rep.		Date Revised	
Applicable Model  Mazda6 (GJ) with AT	Applicable Countries or Specifications  Worldwide

## Subject: AT Shift Lever is hard to move when shifting into P or other ranges

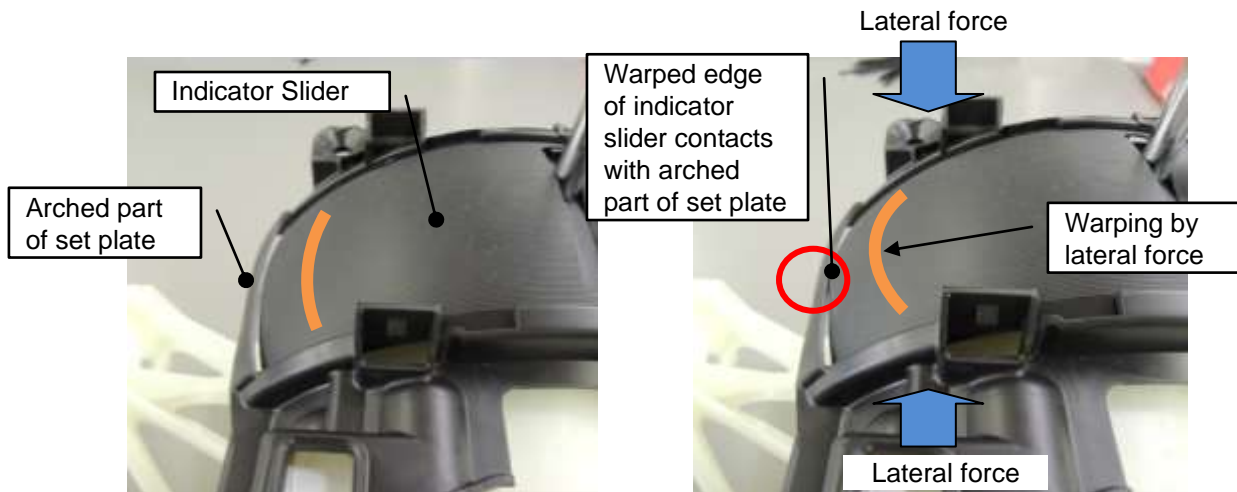
In case a lateral force, by touching of the passenger or driver's leg, is applied to the center console, the indicator slider may be deformed which causes the edge to contact with the arched part of the set plate when moving the AT shift lever. This may cause damage to the indicator slider and generate heavy AT shift lever movement.

-Normal condition-

-Indicator slider deformed by lateral force-

When you encounter a customer complaint on this concern, use the following repair procedure to replace the damaged indicator slider with a new one and cut off pieces from the set plate and the front console to prevent interference between parts when a lateral force is applied.
