Service Information

Category T	Repair Guidance	Ref. No. R090/13A	Page 1 of 5
Coverage <input type="checkbox"/> Distributor only <input checked="" type="checkbox"/> Please inform your dealers		Date Issued November 7, 2013	
Please convey this information to your <input type="checkbox"/> Director <input checked="" type="checkbox"/> General Manager <input checked="" type="checkbox"/> Warranty Dept. <input checked="" type="checkbox"/> Parts Dept. <input checked="" type="checkbox"/> Training Dept. <input checked="" type="checkbox"/> Field Rep.		Date Revised July 2, 2014	
Applicable Model Mazda6 (GJ) Sedan		Applicable Countries or Specifications Europe, Russia

Subject: Water Entry into Trunk Lid Light at high pressure car washing

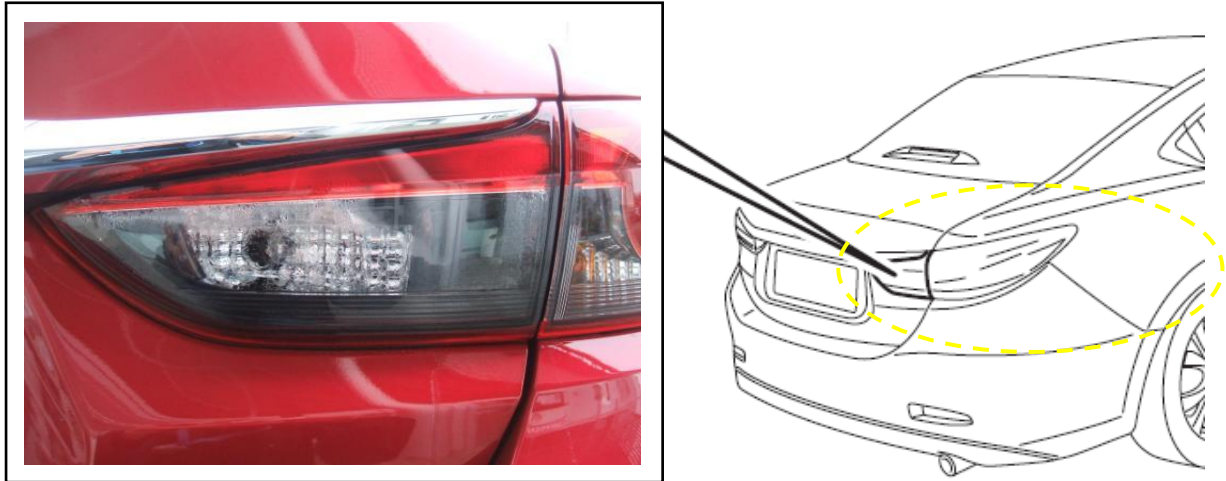
Some vehicles may exhibit a condition that water enters into the trunk lid light while washing the vehicle with a high pressure cleaner.

Water enters through the trunk lid light gasket and the body panel due to a lack of sealing performance against the usage of high pressure cleaner.

To improve sealing performance, the shape of trunk lid light gasket has been changed
