Service Information

Category F	Repair Guidance	Ref. No. R050/14A	Page 1 of 6
Coverage <input type="checkbox"/> Distributor only <input checked="" type="checkbox"/> Please inform your dealers		Date Issued June 12, 2014	
Please convey this information to your <input type="checkbox"/> Director <input checked="" type="checkbox"/> General Manager <input checked="" type="checkbox"/> Warranty Dept. <input checked="" type="checkbox"/> Parts Dept. <input checked="" type="checkbox"/> Training Dept. <input checked="" type="checkbox"/> Field Rep.		Date Revised July 10, 2014	
Applicable Model Mazda3 (BM), Mazda6 (GJ) and CX-5 (KE) with SKYACTIV Engine & i-ELOOP		Applicable Countries or Specifications Worldwide (Except North America)

Subject: i-Stop Warning Light flashing, Master Warning Light illumination and a message “i-ELOOP Malfunction” (BM) / “i-ELOOP Inspection Required” (GJ)&(KE) in LCD (DTC P1794)

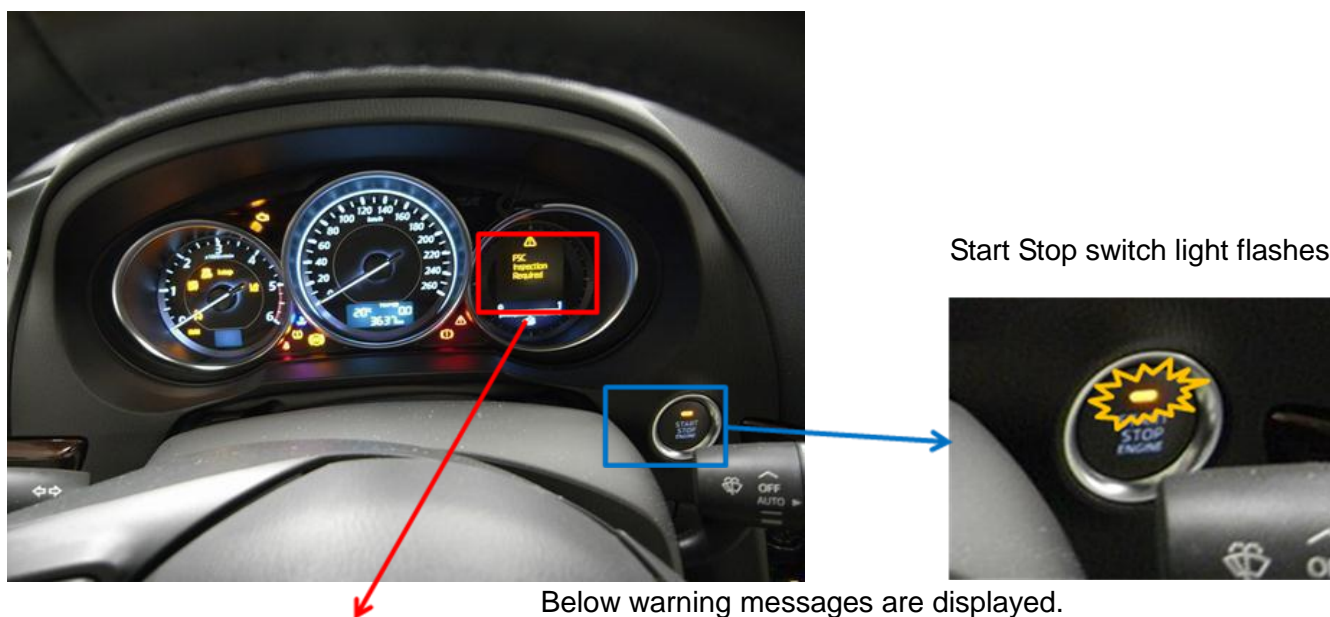
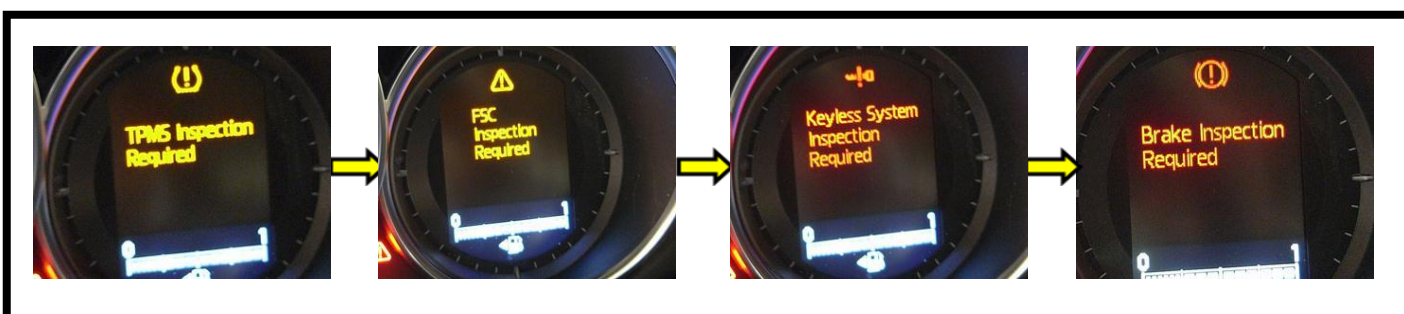
During PCM reprogramming, some vehicles may show some warning messages with flashing Start stop switch. This is caused by reset function of ABS/DSC CU not working properly.

Below warning messages are displayed.

1. Turn the IG-off by pushing Start Stop switch for long time (around 3 seconds) to turn off.
2. After that, disconnect **ABS/DSC S 30A** Fuse for 30 seconds so that the system is reset back to normal.

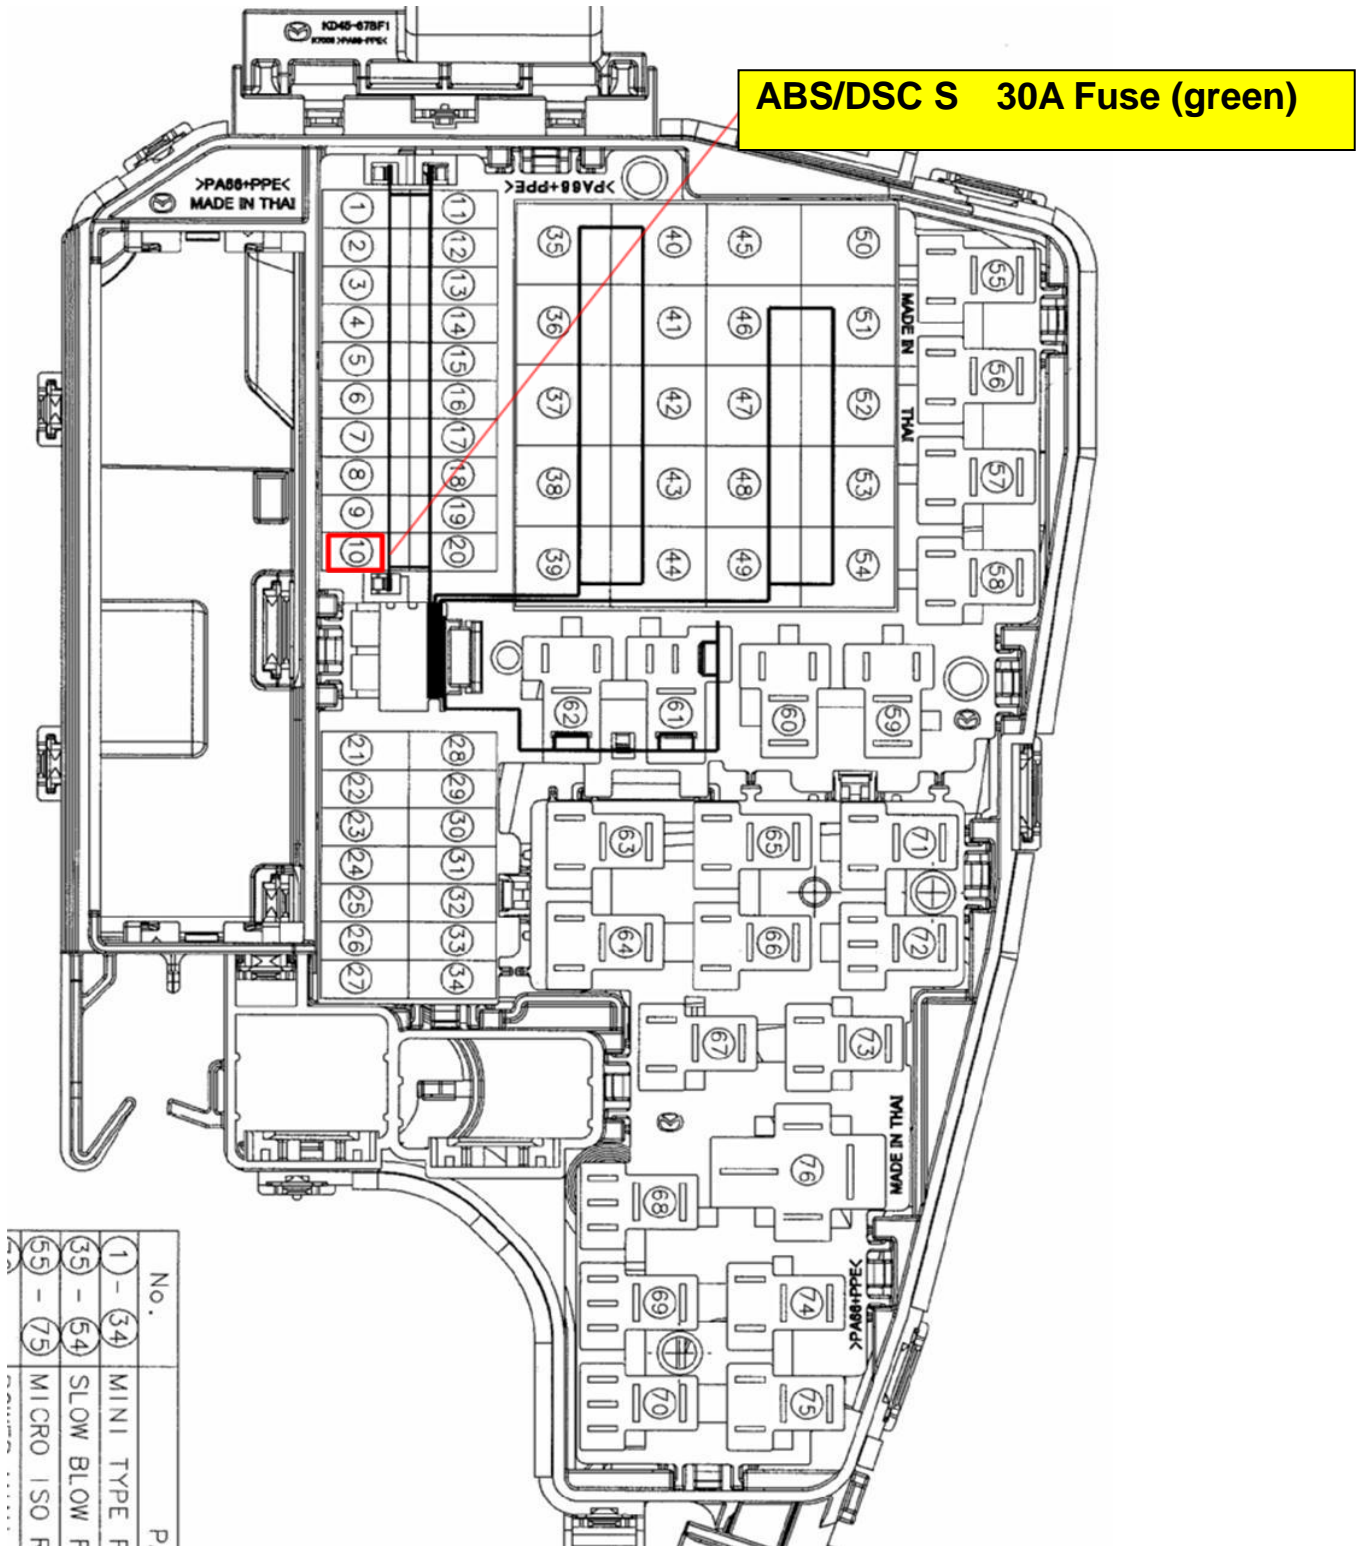
Note: There is similar name fuse "ABS/DSC M 50A, that's wrong one.
