Service Information

Category S	Repair Guidance		Ref. No. R053/14B	Page 1 of 12
Coverage ☐ Distributor only ■ Please inform your dealers			Date Issued June 27, 2014	
Please convey this information to your ☐ Director ☐ General Manager ☐ Warranty Dept. ☐ Parts Dept. ☐ Training Dept. ☐ Field Rep.			Date Revised June 30, 2015	
Applicable Model 2014-2015 MY Mazda6 (GJ) North America Mazda6 (GJ) Europe		Applicable Countries or Special North Ame	cifications erica and Europe	e

Subject: Wind Noise from Front Part of Front Door

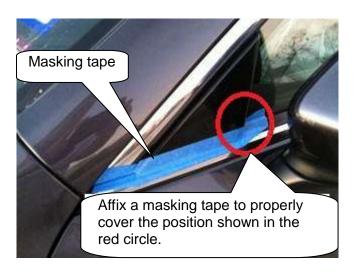
While driving at 60 km/h or more, some vehicles may exhibit a wind noise which is heard around the front part of the front door (around power outer mirror base).

The wind noise may occur when air is passing through minimal gaps between the parts at the front door front edge and the corresponding body panel.

1. Affix a masking tape to the upper part of the front belt line molding as shown in the picture in the next page.
