MULTI-MODEL

POP / CRACK NOISE WHILE DRIVING

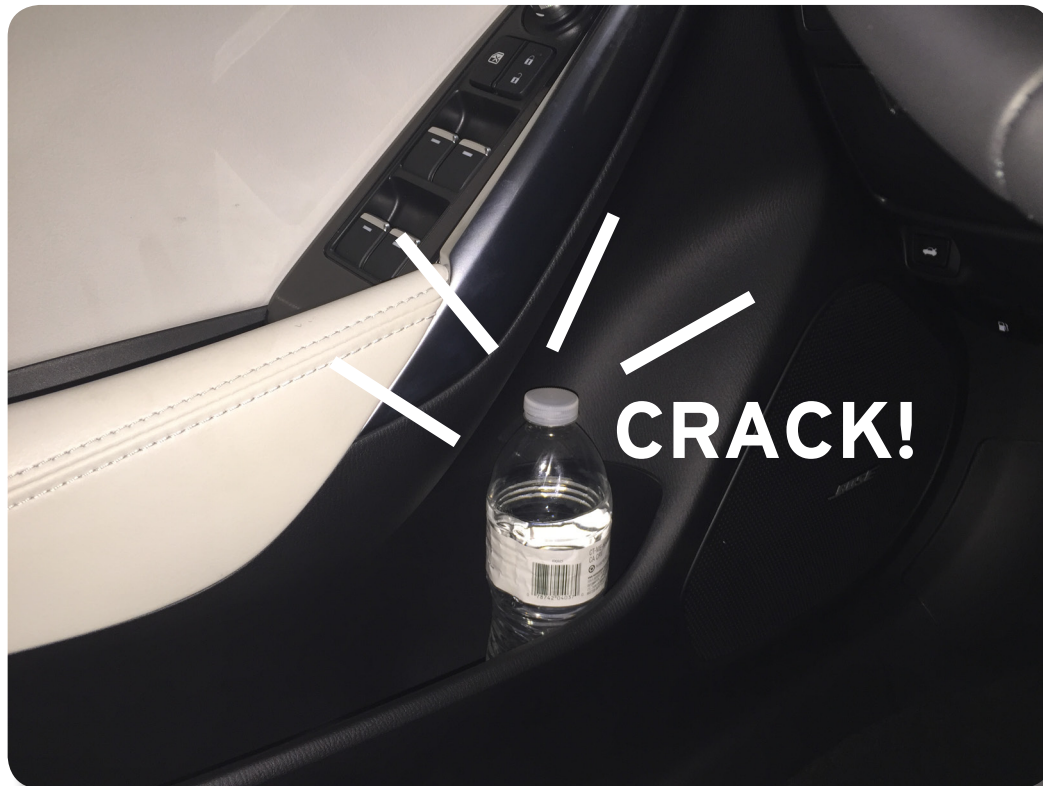
Some customers may complain about an intermittent loud pop or crack type noise while driving. The noise may be caused by a water bottle left in the car.

Water bottles left in a car on a hot day may expand with heat. When the vehicle is driven with the HVAC on, the vehicle interior cools, causing the water bottle to cool and contract (shrink). This may create a loud pop or crack type noise.

No repair is necessary. Explain to the customer that this is a normal condition if water bottles are left in the car.
