Service Information

Category S	Repair Guidance	Ref. No. R041/14A	Page 1 of 7
Coverage <input type="checkbox"/> Distributor only <input checked="" type="checkbox"/> Please inform your dealers		Date Issued May 14, 2014	
Please convey this information to your <input type="checkbox"/> Director <input checked="" type="checkbox"/> General Manager <input checked="" type="checkbox"/> Warranty Dept. <input checked="" type="checkbox"/> Parts Dept. <input checked="" type="checkbox"/> Training Dept. <input checked="" type="checkbox"/> Field Rep.		Date Revised August 26, 2014	
Applicable Model Mazda3 (BL), Mazda6 (GJ), CX-5(KE)		Applicable Countries or Specifications Worldwide

Subject: Cracking Noise from Windshield and/or rear window

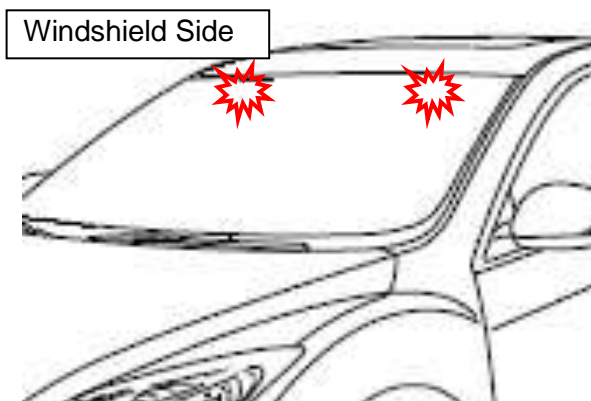
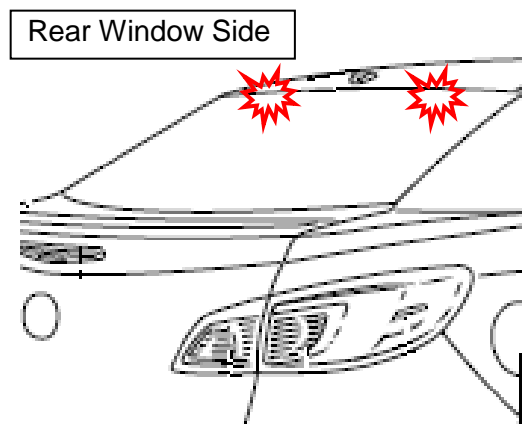
Some vehicles may exhibit a cracking noise originated at the positioning pins near the top corners of the windshield and/or rear window when driving on uneven road surface with ambient temperatures of approximately minus 10 degrees C or lower and the vehicle cabin not yet being warmed up.

This noise is caused by the windshield and/or rear window locating stopper contacting the panel.

When you encounter a customer complaint on this concern, cut the end of the stopper and bend the panel at the affected windshield and/or rear window side as per the following procedure.
