# Service Information

Category <b>F</b>	<b>Repair Guidance</b>	Ref. No. R020/14	Page 1 of 3
Coverage <input type="checkbox"/> Distributor only <input checked="" type="checkbox"/> Please inform your dealers		Date Issued February 17, 2014	
Please convey this information to your <input type="checkbox"/> Director <input checked="" type="checkbox"/> General Manager <input checked="" type="checkbox"/> Warranty Dept. <input checked="" type="checkbox"/> Parts Dept. <input checked="" type="checkbox"/> Training Dept. <input checked="" type="checkbox"/> Field Rep.		Date Revised	
Applicable Model  CX-5 (KE) with SKYACTIV-D 2.2		Applicable Countries or Specifications  ADR, EC

## Subject: Engine Oil Warning Indication / Warning light ON with “Low engine oil pressure” message on LCD and DTC P253F:00 stored in memory

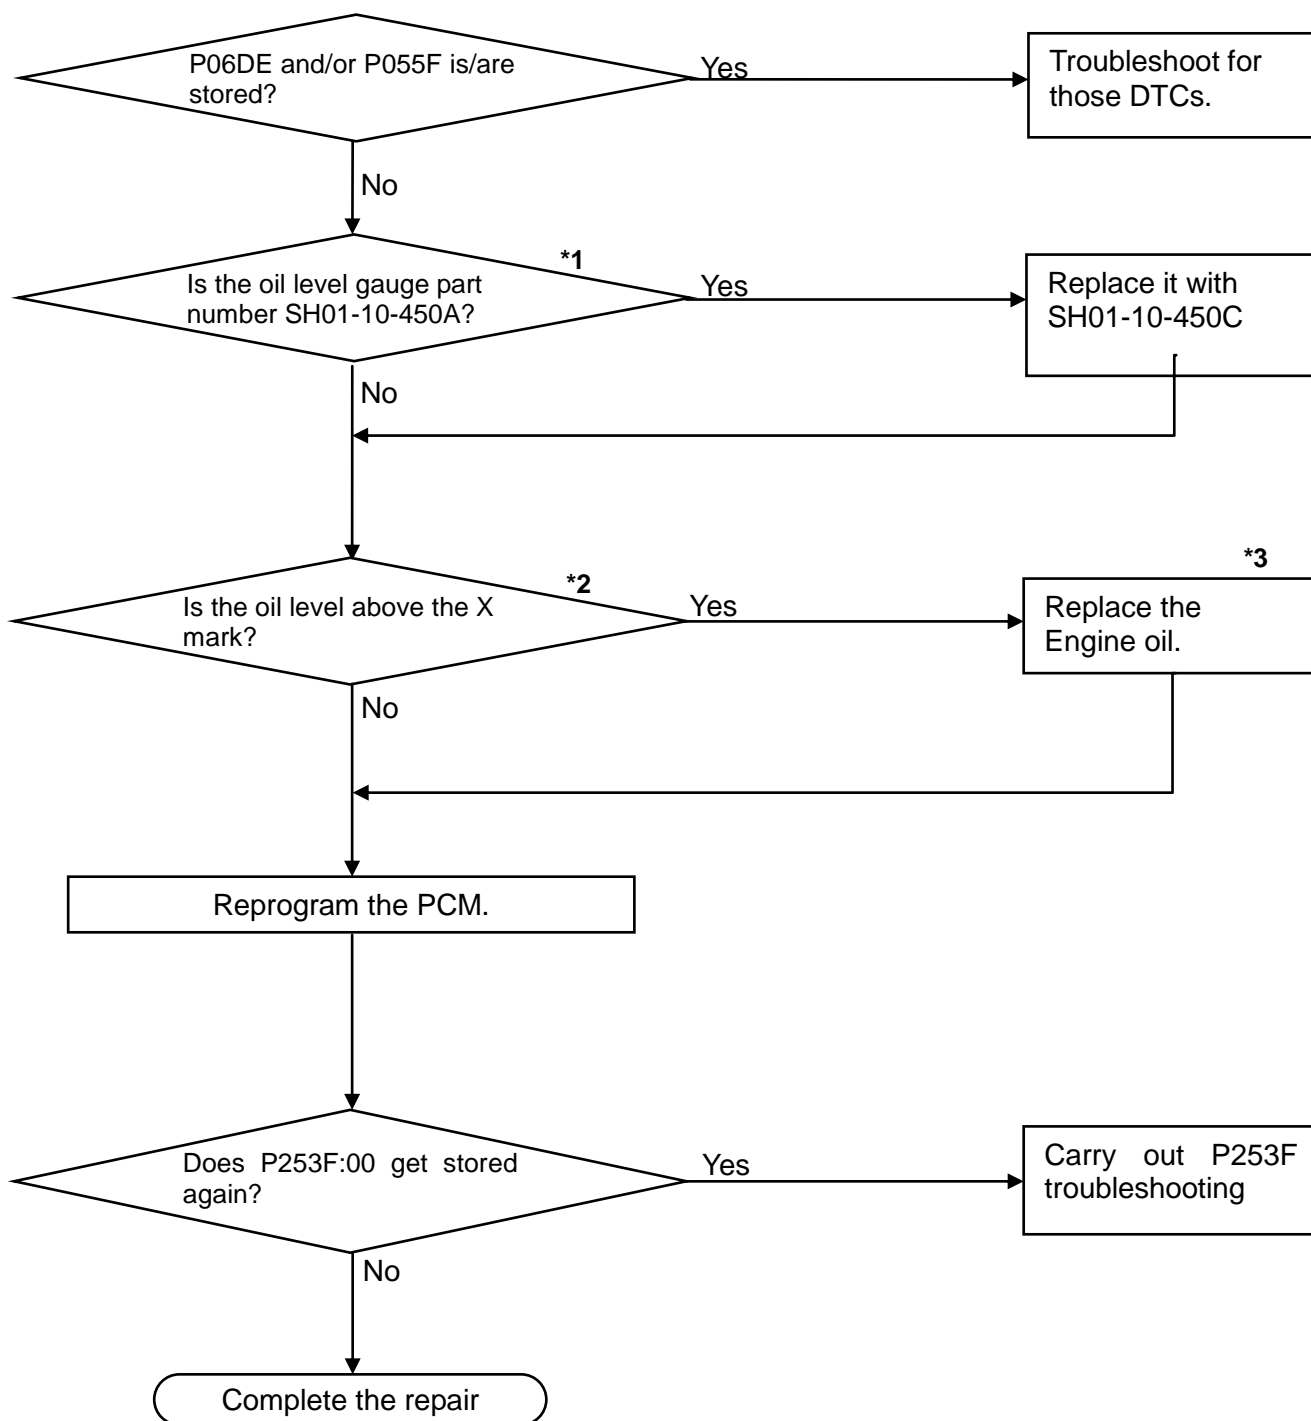
\*1: Part number is stamped on the Oil level gauge.

\*2: Refer SI E057/12 for the oil level checking procedure.

\*3: The oil replacement cost is not covered by warranty, because it is caused by the customer's driving pattern.

1. If P06DE and/or P055F are stored, complete the troubleshooting for those DTCs.
2. If the engine oil level is above X mark (measure oil level using modified level gauge SH01-10-450B or later), replace the engine oil.
3. Reprogram the PCM with the Mazda Modular Diagnostic System (M-MDS) using IDS 87.06 or later software, or IDS 88.01 or later software.
4. If DTC P253F:00 gets stored again, this service information is not applicable. Troubleshoot the concern according to the diagnostic procedure for P253F:00 in the workshop manual.
