Service Information

Category F	Repair Guidance	Ref. No. R009/13	Page 1 of 2
Coverage <input type="checkbox"/> Distributor only <input checked="" type="checkbox"/> Please inform your dealers		Date Issued January 24, 2013	
Please convey this information to your <input type="checkbox"/> Director <input checked="" type="checkbox"/> General Manager <input checked="" type="checkbox"/> Warranty Dept. <input checked="" type="checkbox"/> Parts Dept. <input checked="" type="checkbox"/> Training Dept. <input checked="" type="checkbox"/> Field Rep.		Date Revised	
Applicable Model Mazda6 (GJ) with SKYACTIV-D 2.2 with Auto Cruise		Applicable Countries or Specifications ADR, Europe

Subject: Wrong indication i-ELOOP gauge when driving with auto cruise ON

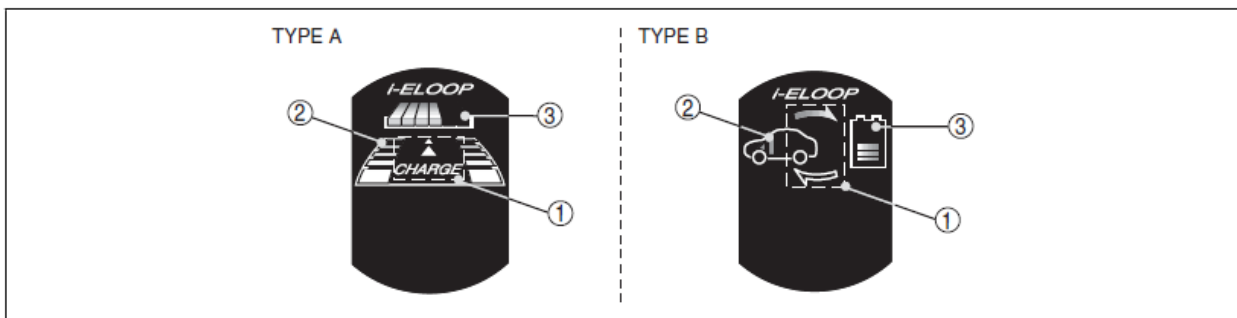
aatjn00001746

1. Regenerative deceleration power generation condition gauge indicates that i-ELOOP is generating electricity using deceleration energy by the display of “CHARGE” for TYPE A or “Arrows” for TYPE B.
2. Regenerative deceleration power generation amount gauge is fixed at 3 scales.
3. Capacitor (i-ELOOP) accumulation amount gauge does not increase.

1.	Regenerative deceleration power generation condition gauge	Displays the direction in which power is moving from the regenerative deceleration power generation.
2.	Regenerative deceleration power generation amount gauge	Displays the amount of power generated by regenerative deceleration.
3.	Capacitor (i-ELOOP) accumulation amount gauge	Displays the amount of electrical power stored in the Capacitor (i-ELOOP).

Improper logic of PCM

The control logic of PCM has been changed.

1. Reprogram the PCM with M-MDS using IDS 82.04 or later software, or IDS 83.01 or later software.
