<b>Subject:</b> HESITATION / IDLE VIBRATION DUE TO CRACKED ENGINE MOUNT	<b>Bulletin No:</b> 01-001/09
	<b>Last Issued:</b> 1/20/2009

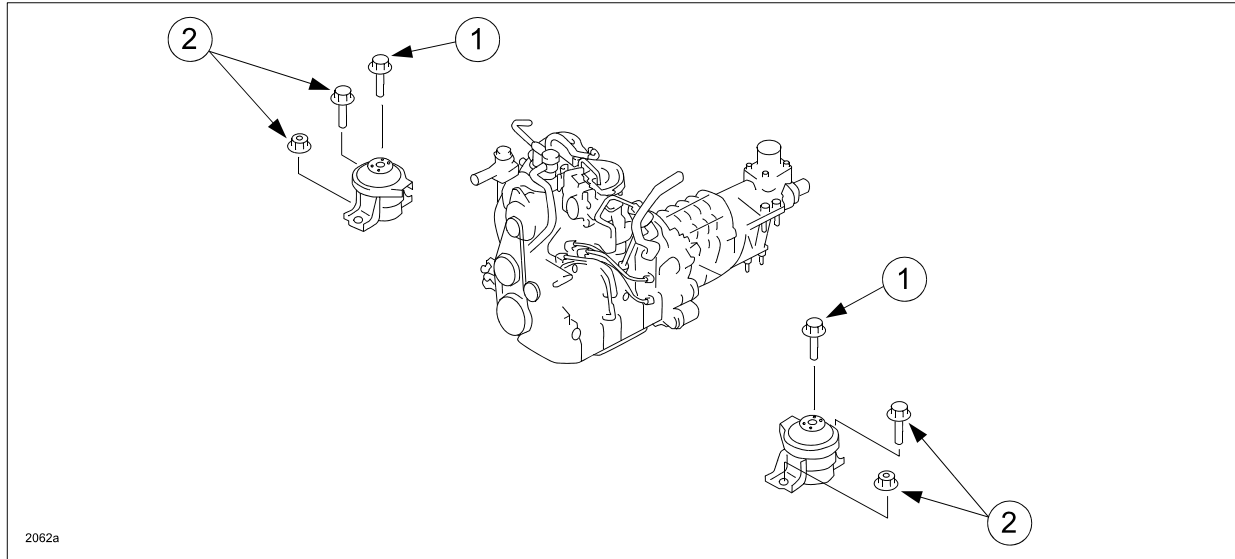
Depending on the driving condition or engine condition, the RH side engine mount rubber may deform. As a result, the RH side engine mount can crack. As a mass production change, the material of the engine mount rubber has been changed.

7. On RH side of engine, remove bolts/nuts in the following order:

- a. Engine mount bracket-to-engine mount (1).  
**Tightening Torque: 37-52 N.m (28-38 ft-lb)**
- b. Engine mount-to-front sub frame (2).  
**Tightening Torque: 45-63 N.m (33-46 ft-lb)**
