Subject: NOISE FROM FRONT OF VEHICLE / STABILIZER CONTROL LINK BROKEN	Bulletin No: 02-005/08
	Last Issued: 10/23/2008

2004-2008 RX-8 with VINs lower than JM1 FE**** ** 402275 (built before August 28, 2008)

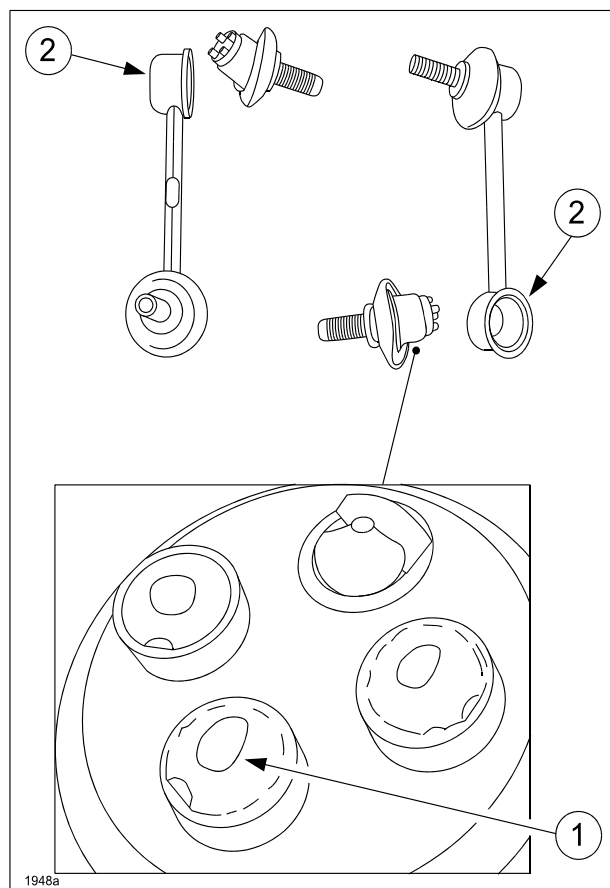
Some customers may complain of an unusual noise from the front of the vehicle. The plastic insert connecting the stabilizer control link ball joint to the control link may crack (1) and become separated (2).

As a result, the stabilizer bar is not connected to the front lower arm, causing the noise. Steering and/or han-

dling is not effected under normal driving conditions.

1. Verify customer concern.
2. Replace left and right stabilizer control links with modified ones. Refer to Workshop Manual section 02-13 FRONT STABILIZER REMOVAL / INSTALLATION.
3. Verify repair.
