# Service Bulletin

Subject:  ENGINE CRANKS NO START	Bulletin No:	01-048/06
	Last Issued:	11/17/2005

2004-2007 RX-8

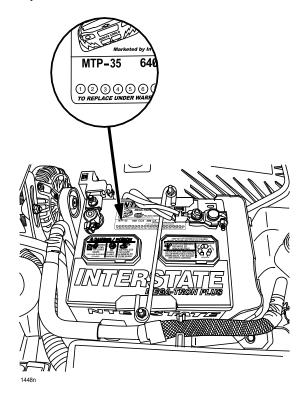
- Interstate brand "MTP35" battery.
  - If the vehicle's battery type matches one of the following descriptions, proceed to STEP 2.
  - If the vehicles battery type does not match the above descriptions, replace with Mazda Genuine replacement battery # 0000-80-6535-WB. Proceed to STEP 3 after battery replacement.
