Subject: REAR QUARTER WINDOW GLASS LOCK BECOMES LOOSE	Bulletin No: 09-011/04
	Last Issued: 4/7/2004

2004 RX-8 - Up to VIN JM1FE173*40120423

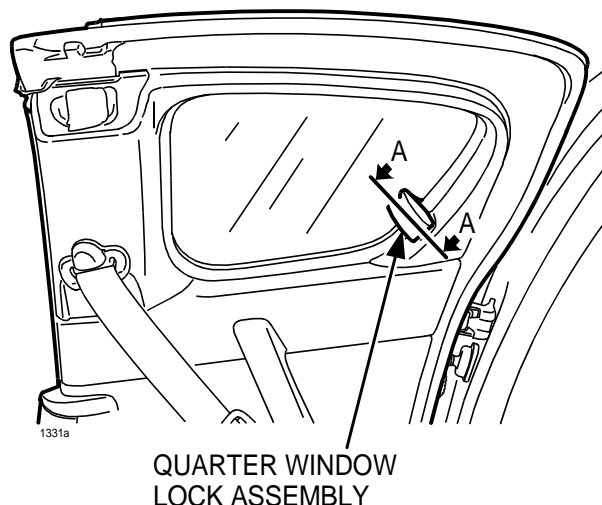
REAR DOOR

Some customers may complain the rear quarter window glass may not stay locked in the open position and closes unexpectedly and/or the rear quarter window glass may not stay locked in the closed position and pops open when a front door is closed.
