Mazda M-TIPS • January/February • 2005

2004-2005 RX-8

P0336 During Engine Start

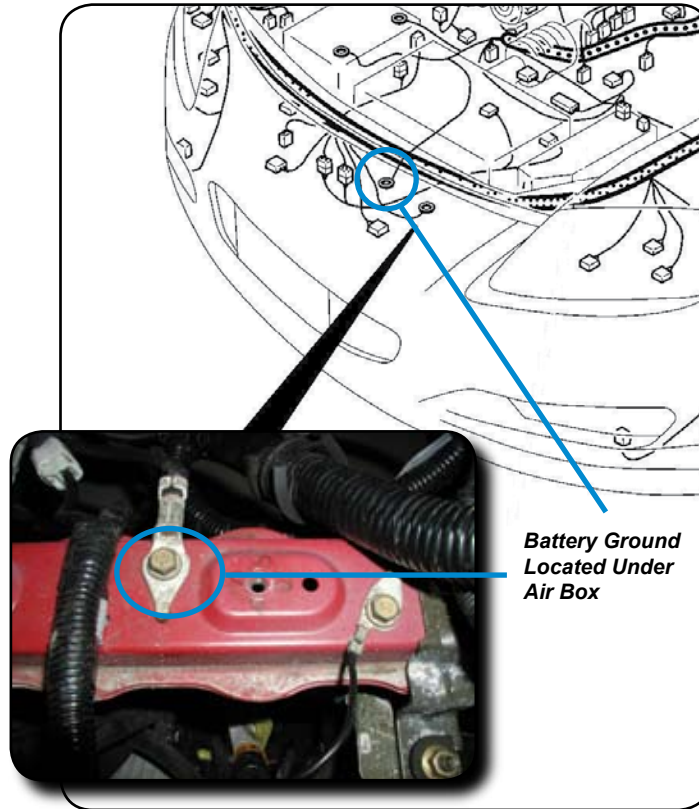
Some vehicles may experience a DTC P0336 (eccentric shaft position sensor range/performance) at time of engine start. The cause may be due to a loose/poor battery ground located on the front core support. Perform the following procedure to identify possible cause:

1. Verify customer concern.
2. Remove engine cover.
3. Remove battery box cover.
4. Locate battery ground wire attachment point to core support. Ground is located between battery box and air cleaner box (Black with red tracer, held to body with 10MM bolt).
5. Clean and tighten ground contact to body.
6. Verify repair.
