M-TIPS

Mazda M-TIPS • January/February • 2005

2004-2005 RX-8

Engine Stalls After Replacement

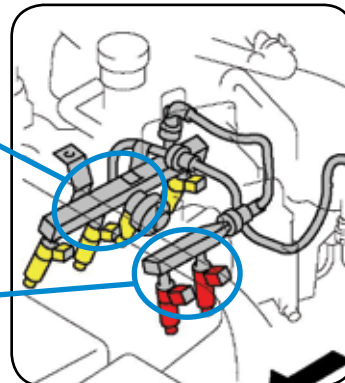
The cause may be due to incorrect routing/attachment of primary and secondary fuel injector harness connectors, or incorrect position of fuel injectors.

Visually inspect primary and secondary fuel injector harness connectors (harness connectors can be seen from front of engine, between upper intake manifold and engine). Primary fuel injectors (Red injectors, all models) are located in the intermediate housing (top of engine). Secondary fuel injectors (4 Yellow injectors on MT, 2 Blue injectors on AT) are mounted in the intake manifold.

The primary injector harness has two colored pieces of tape (White and Tan) near each connector. The secondary injector harness has no tape markings. The connector with White tape connects to the front primary injector. The connector with Tan tape connects to the rear primary injector.

*Secondary Fuel Injectors
(MT Shown)*

Primary Fuel Injectors

If harness connections are not as described, remove upper intake manifold assembly according to Workshop Manual section 01 and route connectors to their proper location.
