MULTI-MODEL EXCESSIVE CONDENSATION OR WATER WITHIN THE HEADLAMP ASSEMBLY

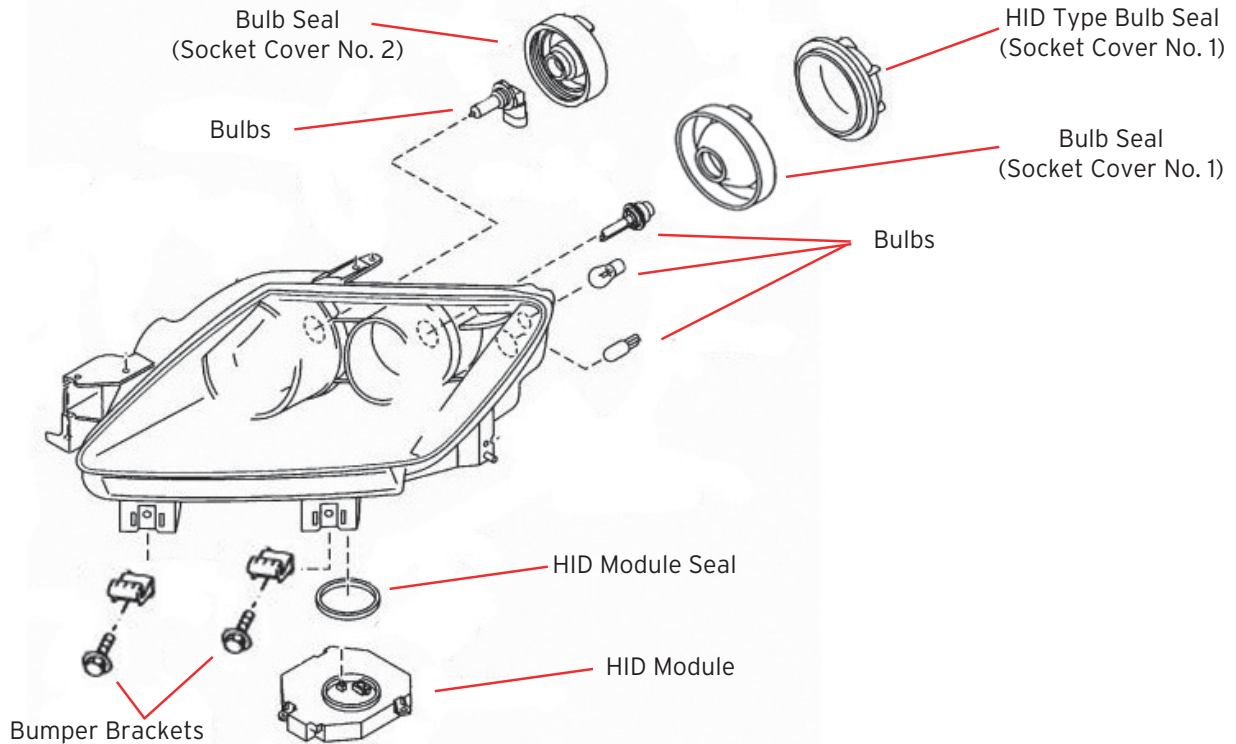
RI 7530

When dealing with customer complaints of excessive condensation and/or water within the headlamp unit, first determine if all the bulb sockets are present and correctly installed. In most cases you will find that the No. 1 and No. 2 socket covers have not been correctly installed or are missing due to improper prior repairs (i.e., customer replacing the headlamp bulbs or body shop not transferring them when replacing the headlamp unit(s) due to a collision). Any damage caused by missing socket covers is not covered by warranty.
