M-TIPS

2004 RX-8

Grease Oozing From Audio Switch

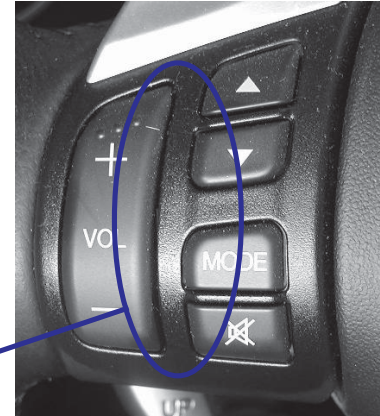
On some vehicles, grease may ooze from the steering wheel mounted audio control switches. The cause of this concern is an excessive amount of grease applied at time of manufacture. This has resulted in a mass production change and the audio control switch has been modified.

**Grease Will Be Noticeable
In This Area**

Customers with this concern should have their vehicles inspected and repaired as necessary. Replace defective switch with a modified one. Refer to Workshop Manual section 09-20-17 AUDIO CONTROL SWITCH REMOVAL/INSTALLATION.
