## MULTI-MODEL ELECTRICAL CONCERN DUE TO AFTERMARKET DEVICE

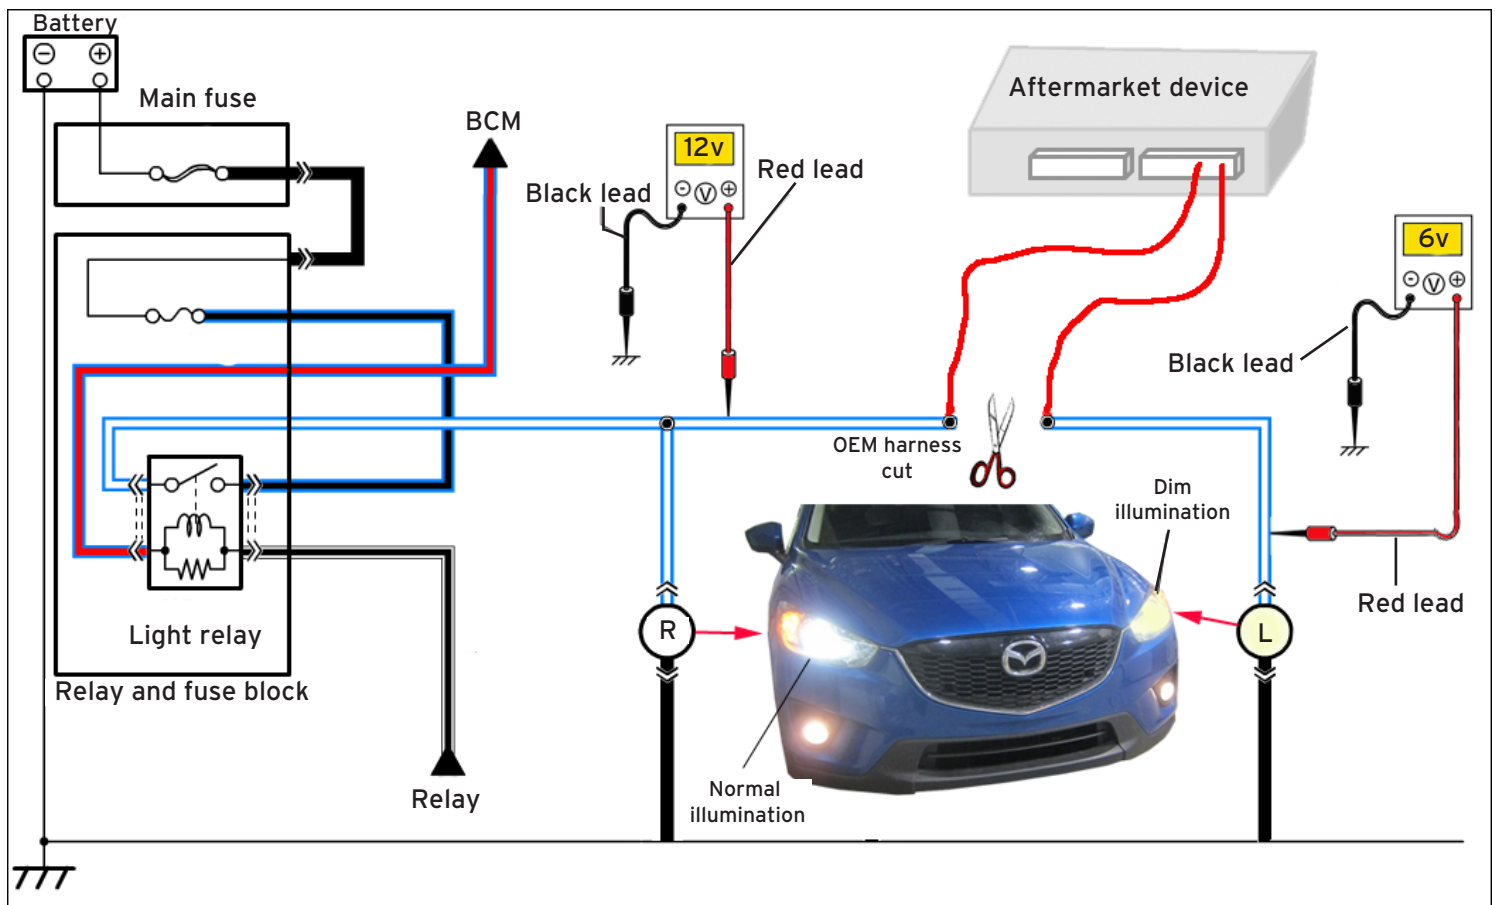
Some aftermarket devices that are wired to the vehicles's wiring harness may create unusual electrical symptoms and/or store DTCs. Below is an example of a dim headlight. The aftermarket device changed the headlight circuit resistance, causing a dim headlight.

If you determine that no aftermarket devices have been installed, continue with normal Workshop Manual diagnosis.

**Note:** If you determine the concern was caused by an aftermarket device, inform the customer that vehicle repairs will not be covered by Mazda's New Vehicle Limited Warranty.
