## MULTI-MODEL

### MIL ON WITH DTC P0171 AND/OR ROUGH IDLE

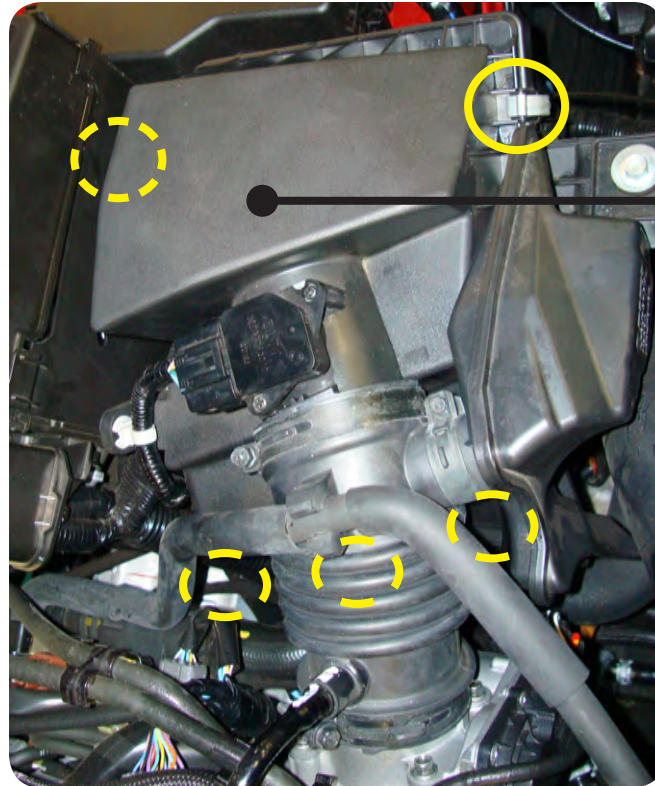
**Note:** A 2011 Mazda3 air cleaner cover is shown. Other model air cleaners are similar.

When replacing or inspecting the air cleaner element, make sure the air cleaner cover is properly secured to the lower air box. Some air cleaner covers have 3 inserts on one side and 2 anchors on the other side. A MIL may be stored and/or a rough idle may occur if the air cleaner cover is not installed correctly.

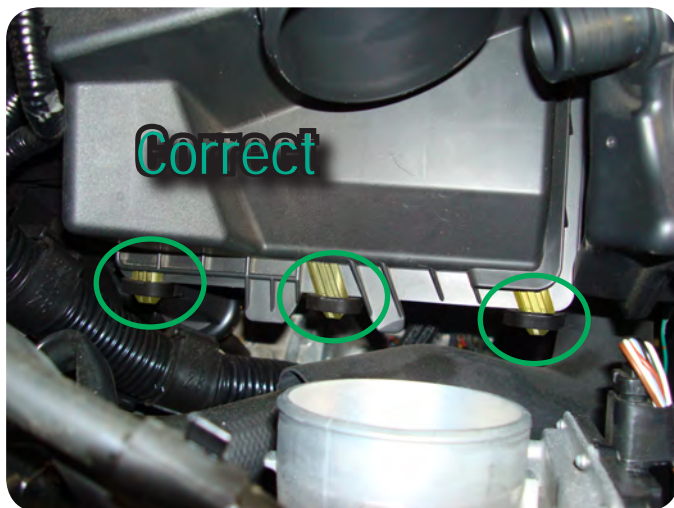
Left side of the air cleaner cover is inserted into the lower air cleaner housing correctly.

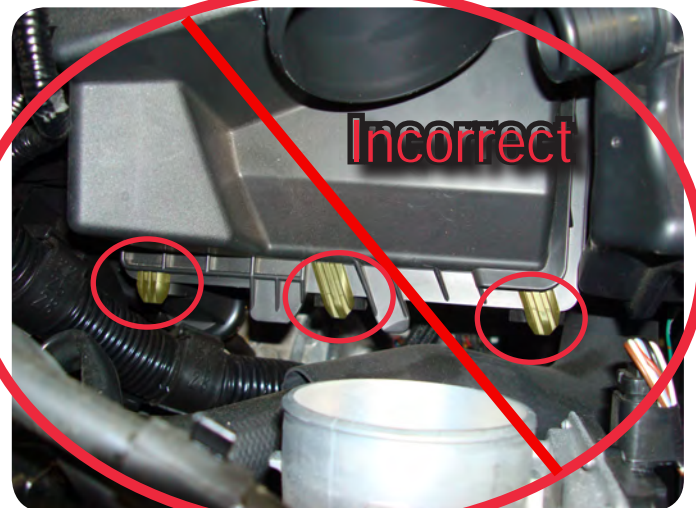
Left side of the air cleaner cover is not inserted into the lower air cleaner housing correctly.
