## MULTI-MODEL VEHICLE PULL / DRIFT AFTER TIRE REPLACEMENT

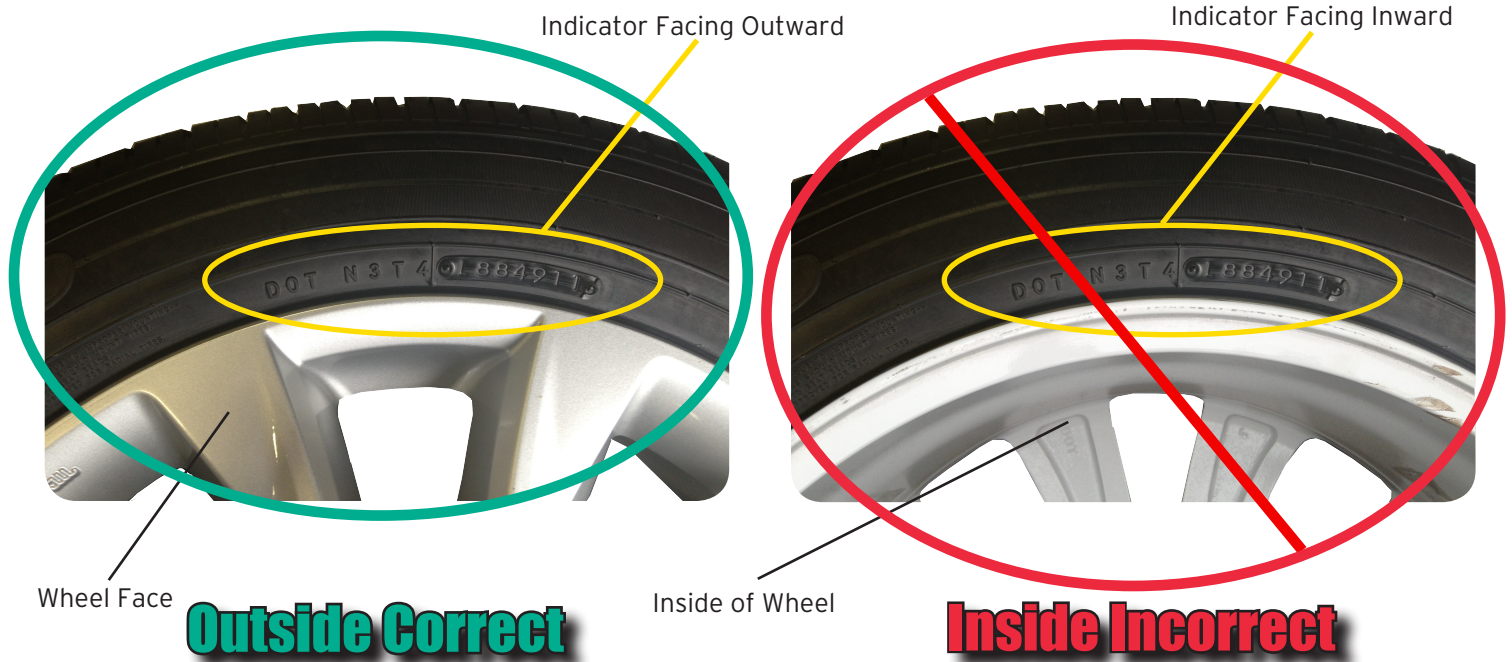
When installing a replacement tire on a customer's vehicle, make note that the tire sidewall indicators below face outward.

- Colored painted dots
- OUTSIDE
- DOT XXXX XXXX XXXX (see example below)

**Note:** DOT XXXX facing inward is normal

Incorrect tire installation may cause the vehicle to drift or pull while driving.

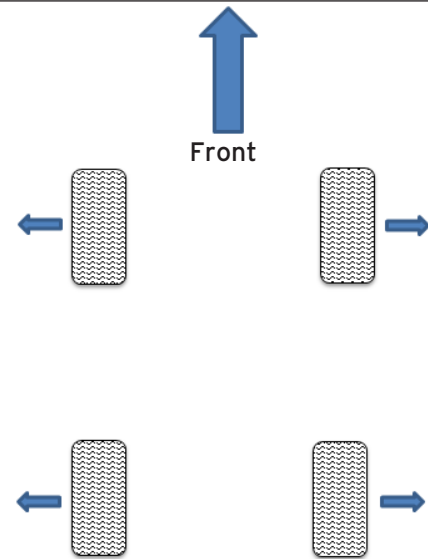
**Correct Tire Installation**

All tires are installed correctly with the indicators facing outward. Lateral forces offset each other. When the vehicle is driven, it drives straight.

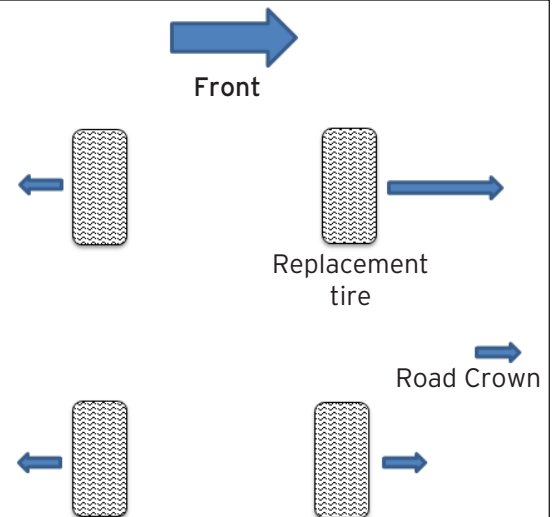
**Correct Tire Installation with Pull/Drift**

All tires are installed correctly with the indicators facing outward. The replacement tire conicity lateral force is sometimes more than the three other tires on the vehicle. This additional lateral force, plus road crown, may cause the vehicle to pull/drift to the right when driven.
