<b>Subject:</b>  AT - SLIGHT SURGE WHILE DRIVING AT 40-55 MPH	<b>Bulletin No:</b> 05-010/06
	<b>Last Issued:</b> 10/24/2006

2006 RX-8 vehicles with AT with VINs JM1FE173\* 60 200016 through 207469

2007 RX-8 vehicles with AT with VINs JM1FE173\* 70 207473 through 208296

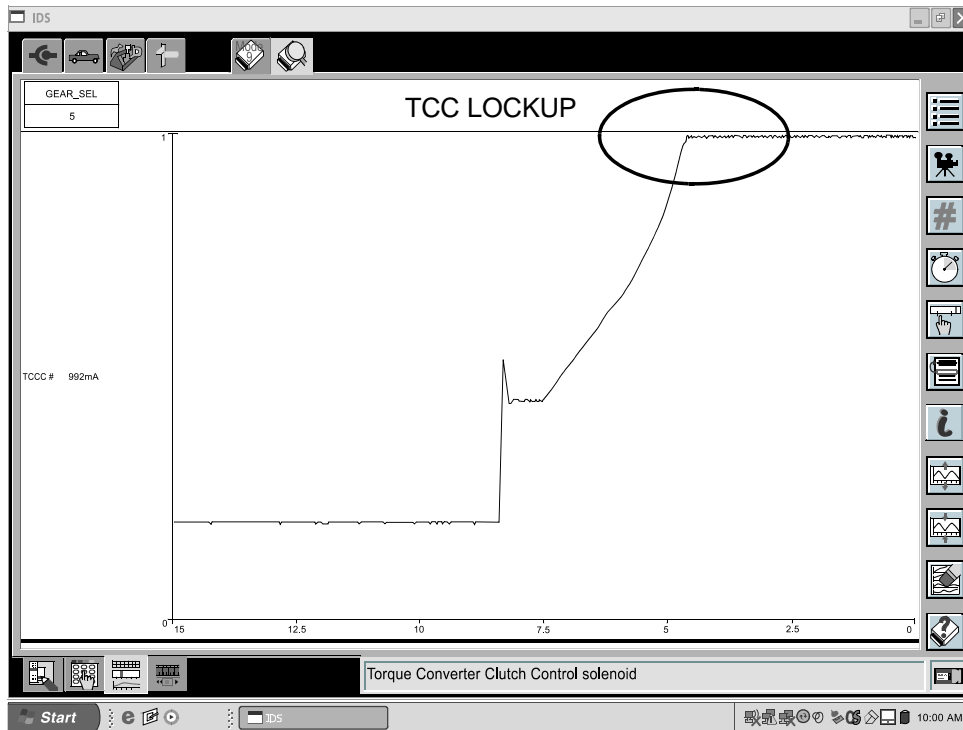
1712a

2. Monitor TCCC # and GEAR\_SEL PIDs while driving. If surging occurs while in 5th gear and TCC is locked, proceed to next step. If surging does not occur, return vehicle to customer.
