<b>Subject:</b> <b>AT - VIBRATION AT 45-60 MPH DURING LIGHT ACCELERATION</b>	<b>Bulletin No:</b> 05-007/08
	<b>Last Issued:</b> 5/22/2008

2006-2008 RX-8 vehicles equipped with 6-Speed AT

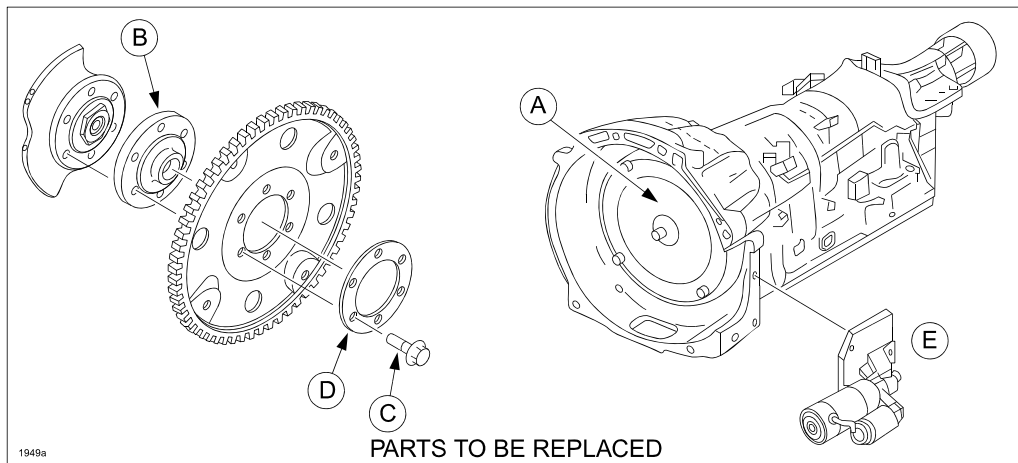
Some customers may complain of body vibration occurring during light acceleration between 45-60 MPH (1600-1900 RPM). This symptom is caused by resonance between the engine and the transmission and occurs during 6th gear lock-up.

7. Replace the torque converter with a modified one (A). Refer to Workshop Manual section 05-13B - TORQUE CONVERTER REMOVAL / INSTALLATION [SJ6A-EL].
8. Replace the adapter (B) with a modified one with new backing plate (D) and modified bolts (C). Refer to Workshop Manual section 05-13B DRIVE PLATE REMOVAL / INSTALLATION [SJ6A-EL].
9. Install transmission. Refer to Workshop Manual section 05-13B AUTOMATIC TRANSMISSION REMOVAL / INSTALLATION [SJ6A-EL].
