Subject: DTC P0336 DURING ENGINE START - SERVICE TIP	Bulletin No: 01-017/05
	Last Issued: 5/20/2005

2004-2005 RX-8

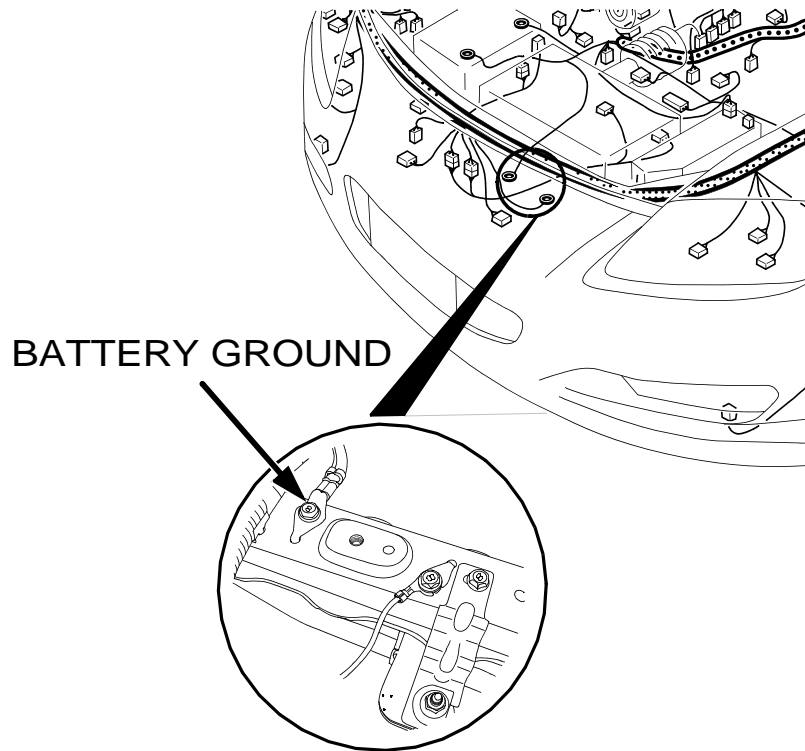
1. Verify customer concern.
2. Remove engine cover and battery box cover.
3. Locate battery ground wire attachment point to core support. Battery ground is located between battery box and air cleaner box (Black with red tracer, held to body with 10MM bolt).

4. Clean/tighten battery ground contact to body.
5. Verify repair.
