Subject: ENGINE COVER GROMMETS MISSING	Bulletin No: 01-001/04
	Last Issued: 3/29/2004

2004 RX8 - Below VIN: JM1FE17**40124611 built before 11-12-2003

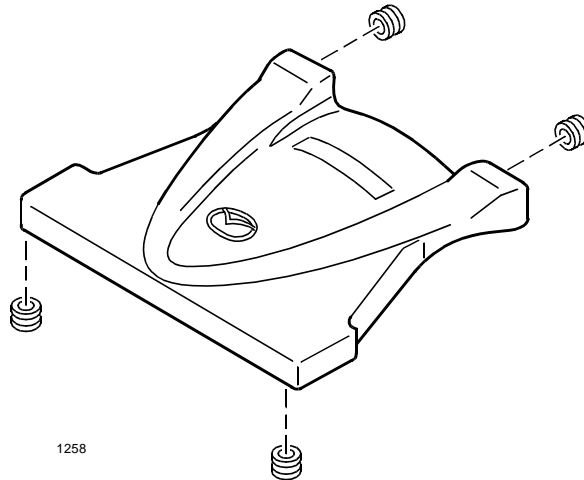
Engine cover grommets may become loose and fall off. A revised engine cover grommet (larger diameter) is available to correct this concern. Vehicles within the VIN range with this condition should be repaired using the procedure below.

1. Remove the engine cover.
2. Replace missing grommets with a revised grommet.
3. Adjust the position of the engine cover and reinstall making sure all grommets are seated properly.
4. Verify repair.
