Service Bulletin

Subject:	Bulletin No:	09-008/07
HEADLIGHT AUTO-LEVELING MALFUNCTION INDICATOR LIGHT ILLUMI-		
NATES	Last Issued:	10/3/2007

APPLICABLE MODEL(S)/VINS

2004-2007 RX-8 with VINs lower than JM1 FE**** ** 210881 (built before November 15, 2006)

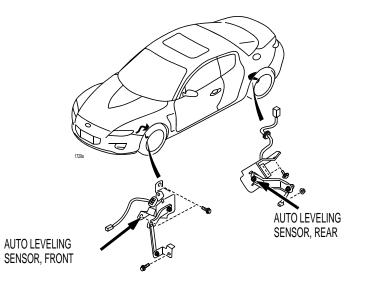
Some customers may complain that the headlight auto-leveling malfunction indicator light illuminates and the auto-leveling function does not work.

Due to connector design, water may enter the auto-headlight leveling sensor(s) through the connector(s), causing corrosion inside the leveling sensor. This can lead to internal failure of the sensor. As a mass production change, the connector has been changed from a normal waterproof type to a heavy duty waterproof type.

Customers having this concern should have their vehicle repaired using the following repair procedure.

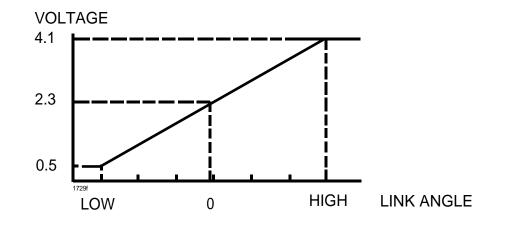
4. Measure voltage while slowly moving the link up and down. The voltage should be liner (smooth) during movement in the range between 0.5 V and 4.1 V.

- If OK, apply waterproof urethane sealer to the short harness connectors. See WATERPROOF SEALER APPLICATION procedure. Then re-install the sensors.
- If one or both sensors are not OK, replace the sensor(s) with a new one along with short harness (short harness is included with new sensor). For short harness replacement, refer to SHORT HARNESS REMOVAL/INSTALLATION procedure.
