Subject: INSTRUMENT PANEL NOISE - DRIVER SIDE	Bulletin No: 09-023/06
	Last Issued: 6/1/2006

2004-2006 RX-8 vehicles with VINs lower than JM1 FE**** ** 201566 (produced before February 2, 2006)

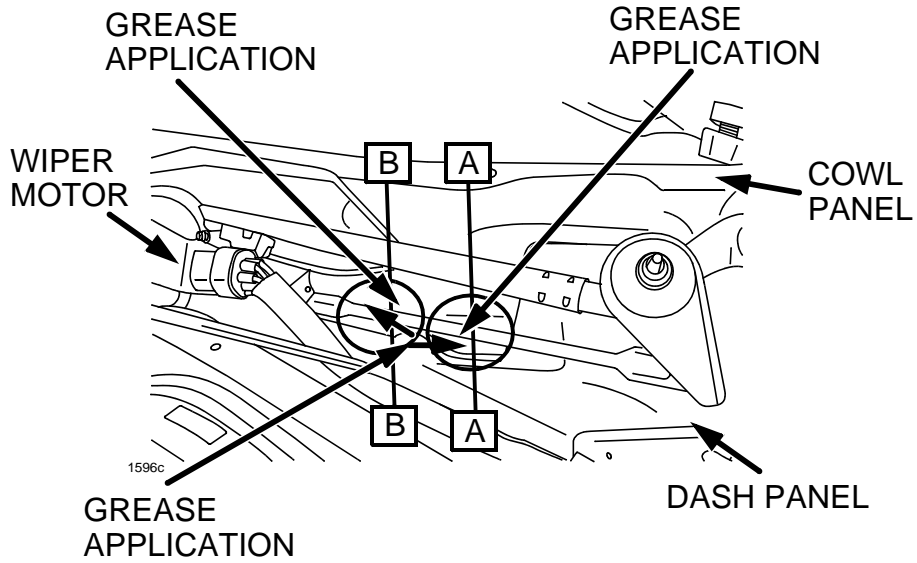
Some vehicles may exhibit a squeaking noise from around the driver-side of the instrument panel. The driver-side dash panel under the cowl grill and cowl panel can become twisted and make contact, causing the noise.

4. Apply waterproof spray grease to mating surfaces between the dash panel and cowl panel as indicated by the circles in the following figure.

- Use locally sourced waterproof spray grease.
